Emerald Ocean Engineering LLC

February 12, 2007

SUBJECT: Pensacola Small Boat Harbor Channel Investigation

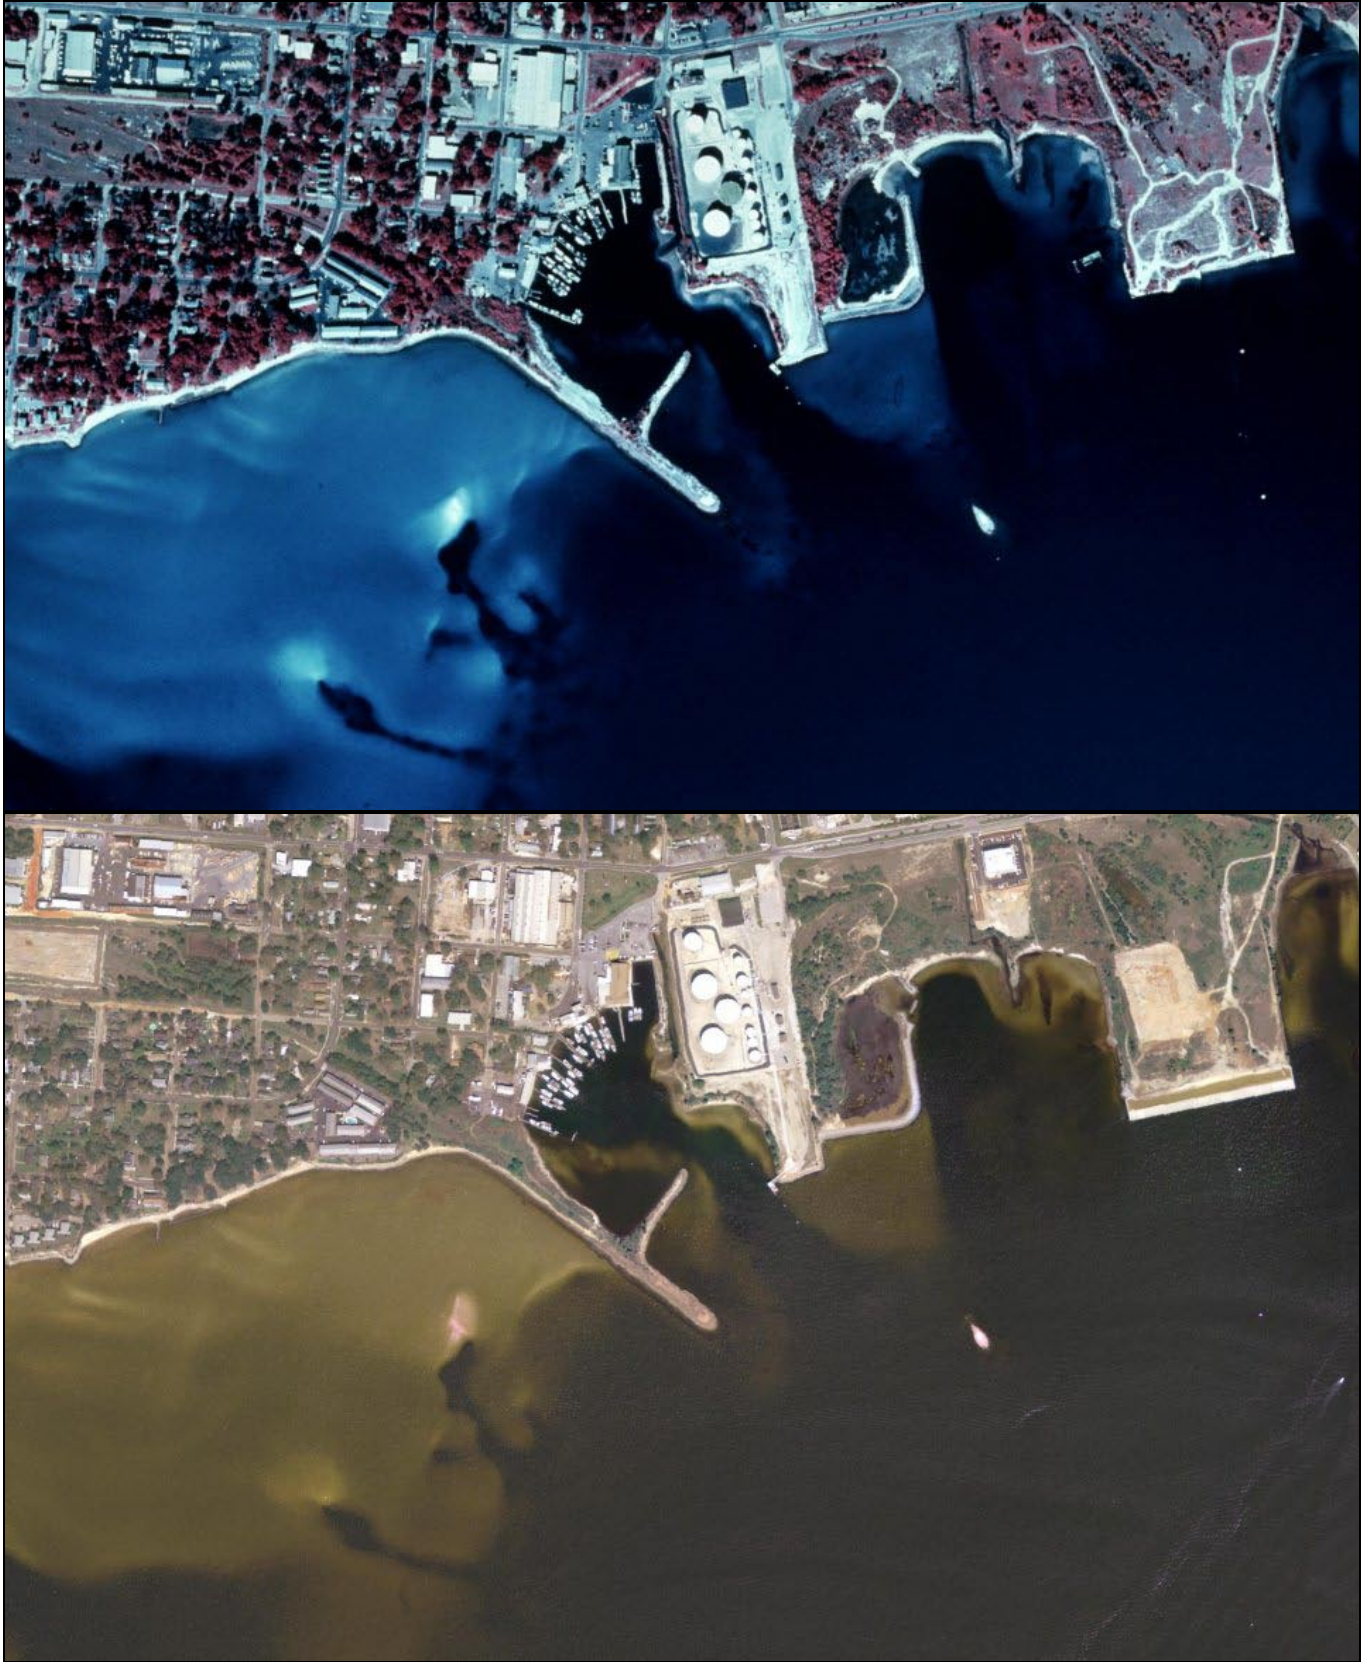
3. These sand flats are typical of the Pensacola Bay shoreline. They are relatively stable, long-term features of the that are not significantly transported under typical (non hurricane) conditions. Figure 3a is a false-color aerial photograph of the harbor and vicinity taken in 1999; Figure 3b is the same area taken in March 2004. There is no discernible difference in the size or shape of the sand flats (at this scale) over the five year interval. Because there are no there are no sources of easily mobilized sand adjacent to or inside the harbor, the sedimentation rate of the channel by wind waves is not significant during typical and normal (non hurricane) storm conditions. Figure 3c is an aerial photograph taken immediately after Hurricane Ivan. There has been little change in the size or shape of the sand flat to the west of the harbor. The sand flats on the western side of the harbor appear to have been lowered, though this visual effect may be partially due to reduced water clarity. The sand flats on the eastern side of the harbor have definitely gotten larger and shallower, and the interior harbor shore protection structures have suffered major damage.

Figure 3 - a) Aerial Photo from November 27, 1999 (top) and b) from March 17, 2004 (bottom)

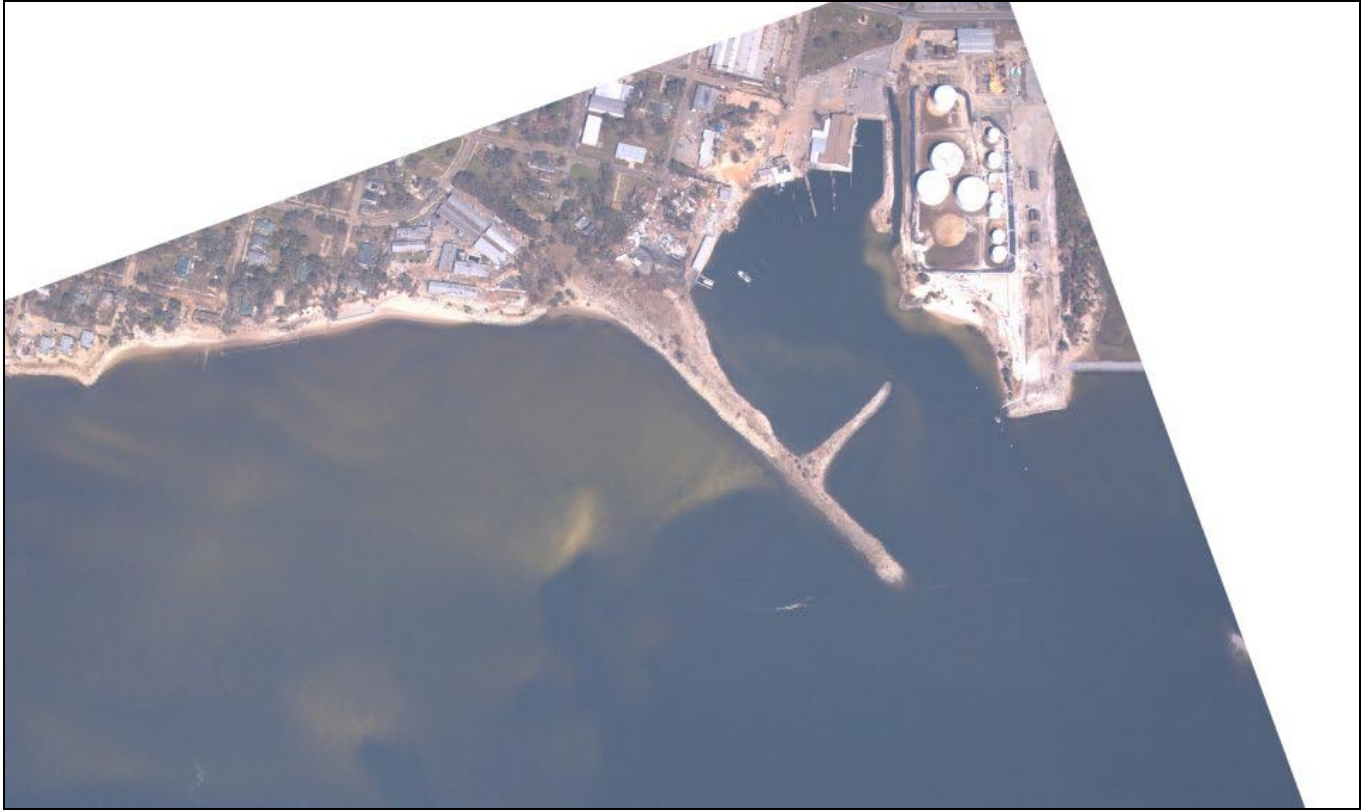
Figure 3 – c) Post-Ivan Aerial Photograph taken September, 2004

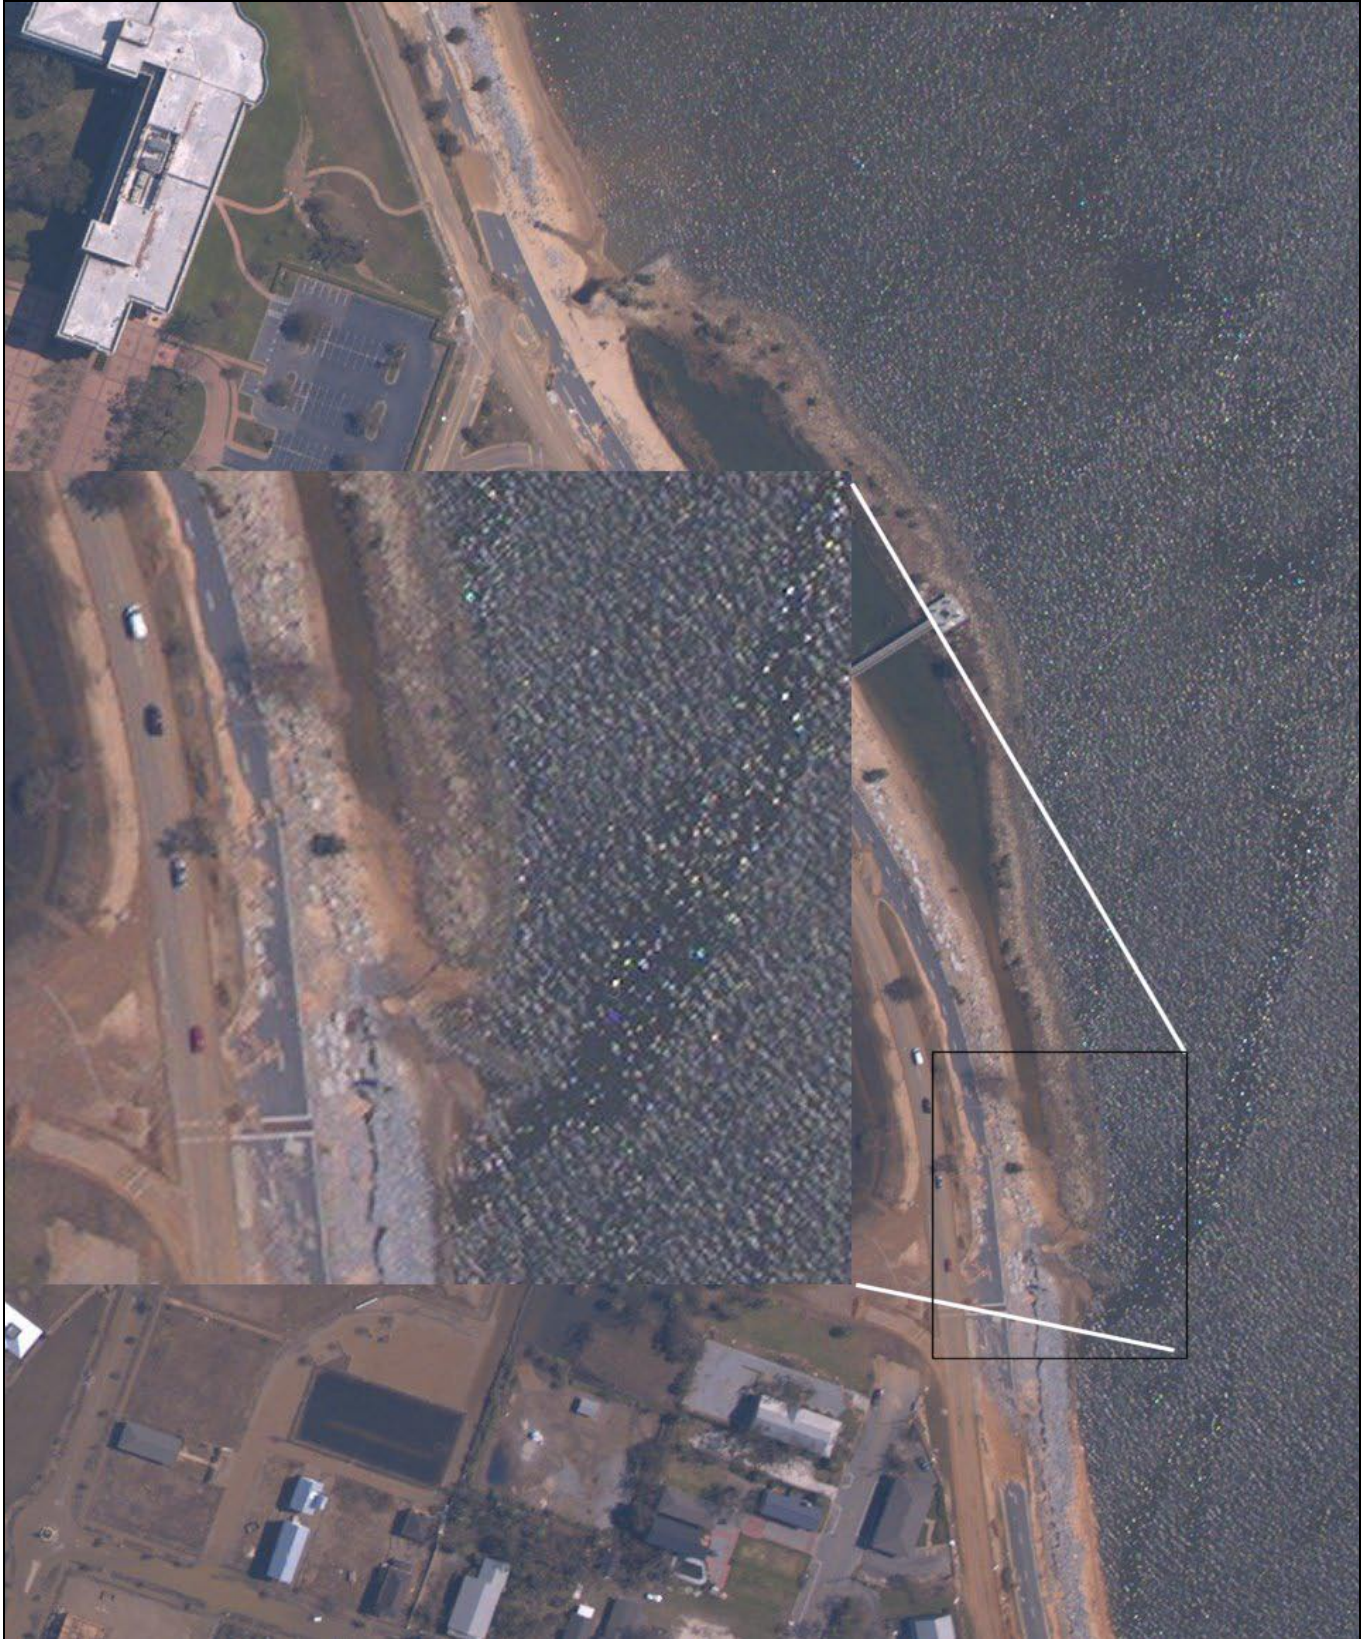
general trend is a flattening of both the onshore and offshore profile; steep shorefaces are eroded and the sand is both pushed landward and pulled seaward. If the duration of the storm is sufficient, the resulting profile is nearly planar from offshore to well beyond the normal waterline. Another general trend is that suspended sediment tends to settle in holes, channels, and inlets. This trend is sustained over a broad range of scales. The US Navy is in the process of instituting an emergency dredging plan to remove 8 M CY of sand from Pensacola Pass (see Figure 1), much of it deposited by Hurricane Ivan. The entrance to Hawkshaw Lagoon, (a small, artificial waterway a few miles east of the PSBH; see Figure 2) remained open without maintenance for years. It was completely filled in by Hurricane Ivan overnight (Figure 4). The orientation of the entrance PSBH placed its opening squarely into the incoming waves during the most intense intervals period Hurricane Ivan. All of the Bay shorelines exposed to these conditions experienced significant erosion. There is every reason to assume that the eroded sediment inside PSBH harbor would likewise tend to settle in the channel.

Figure 4. Posy-Ivan Aerial Photograph of Hawkshaw Lagoon with Entrance (enlarged), taken September, 2004

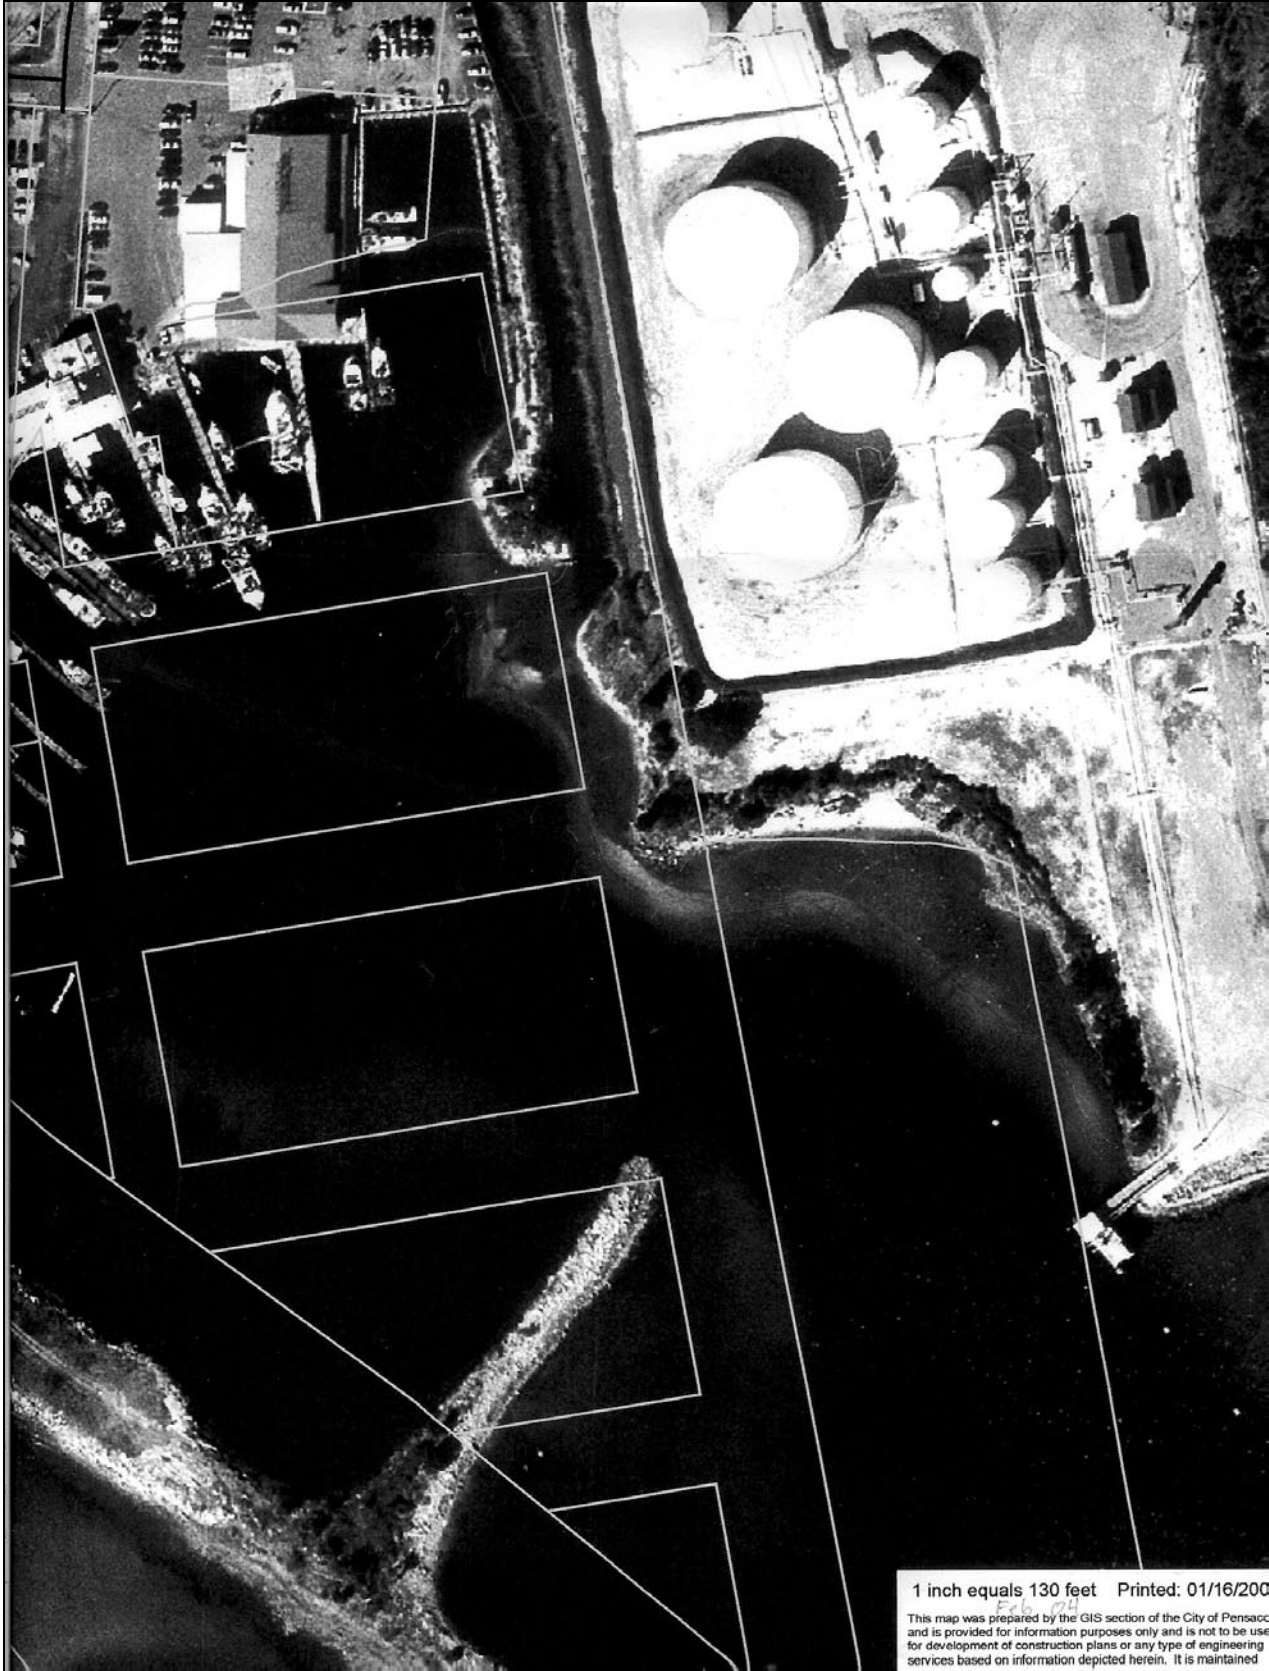
5. Figure 5a is an aerial photograph of the PSBH and channel taken in the first week of February 2003, and Figure 5b is the same area taken on December 17 2004, three months after hurricane Ivan. The impacts to the shoreline are obvious and dramatic: the revetment inside the harbor has been destroyed and sediment from the uplands has been deposited on the formerly submerged sand flats, bringing their elevation to above the waterline. Figure 5c is a composite overlay of the two images to better illustrate the changes. The area of newly deposited subaerial sand is shown crosshatched in Figure 5d with the approximate location of the dredged channel. It is reasonable to assume that a similarly significant amount of eroded sand was also deposited in deeper adjacent water of the channel (beyond the limit of visibility in these photos) by the same processes.

Figure 5 - a) Aerial Photograph of PSBH taken February 2003

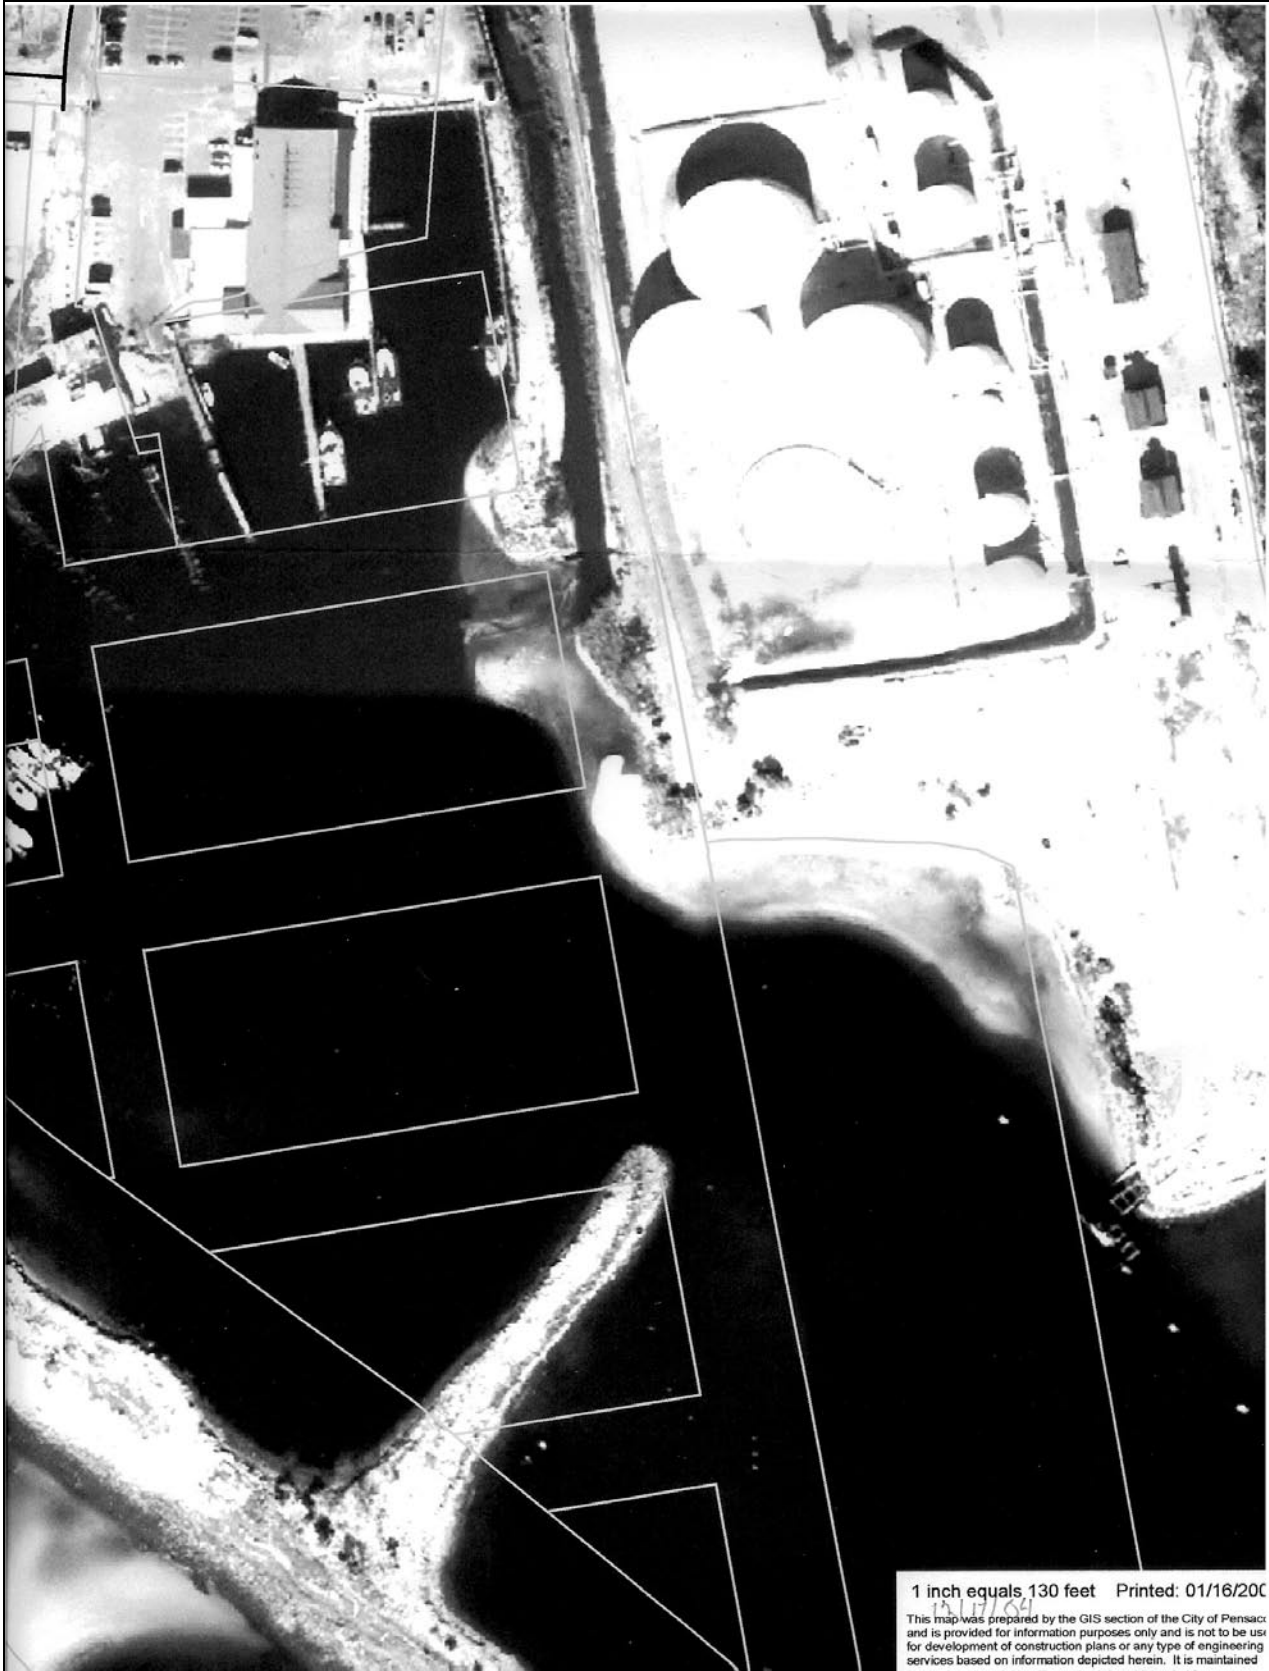
Figure 5 – b) Aerial Photograph of PSBH taken December 2004

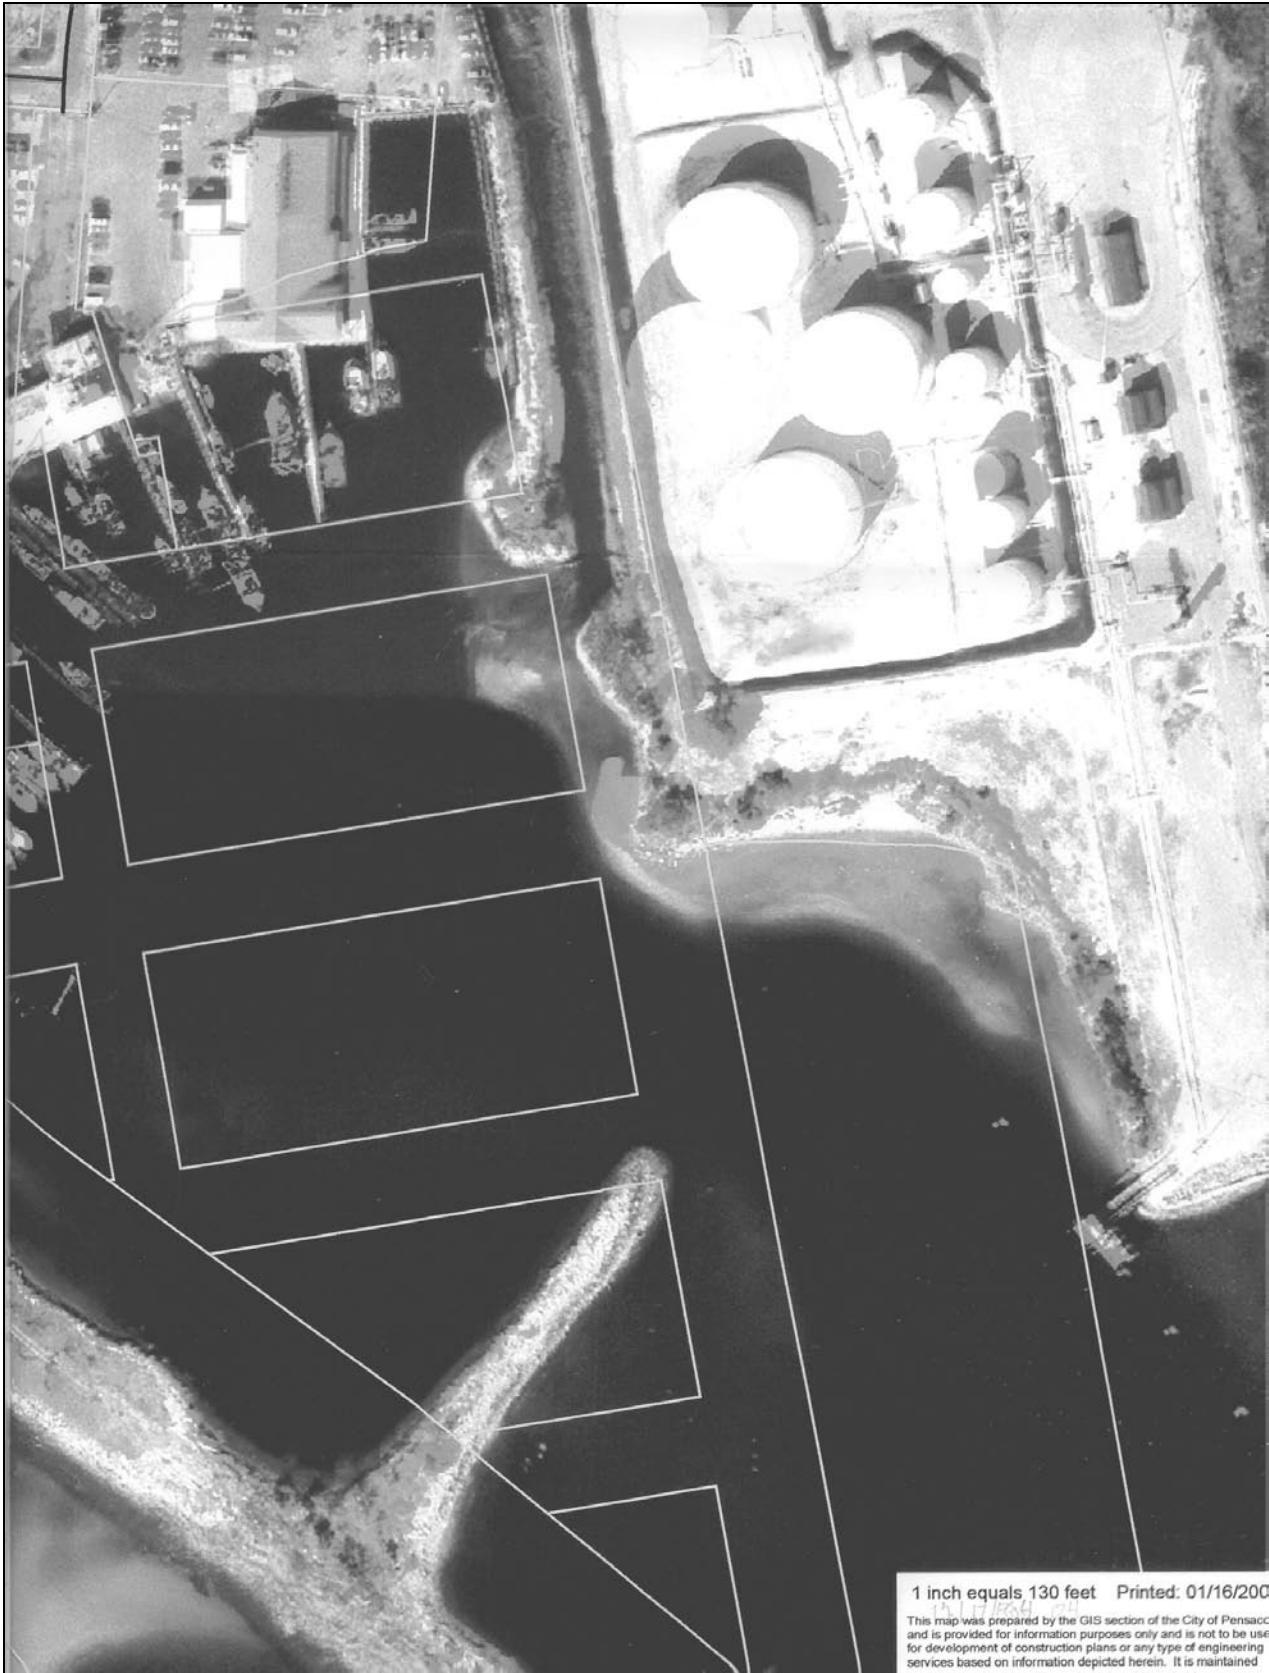
Figure 5 – c) Composite of Pre and Post Ivan Aerial Photographs of PSBH

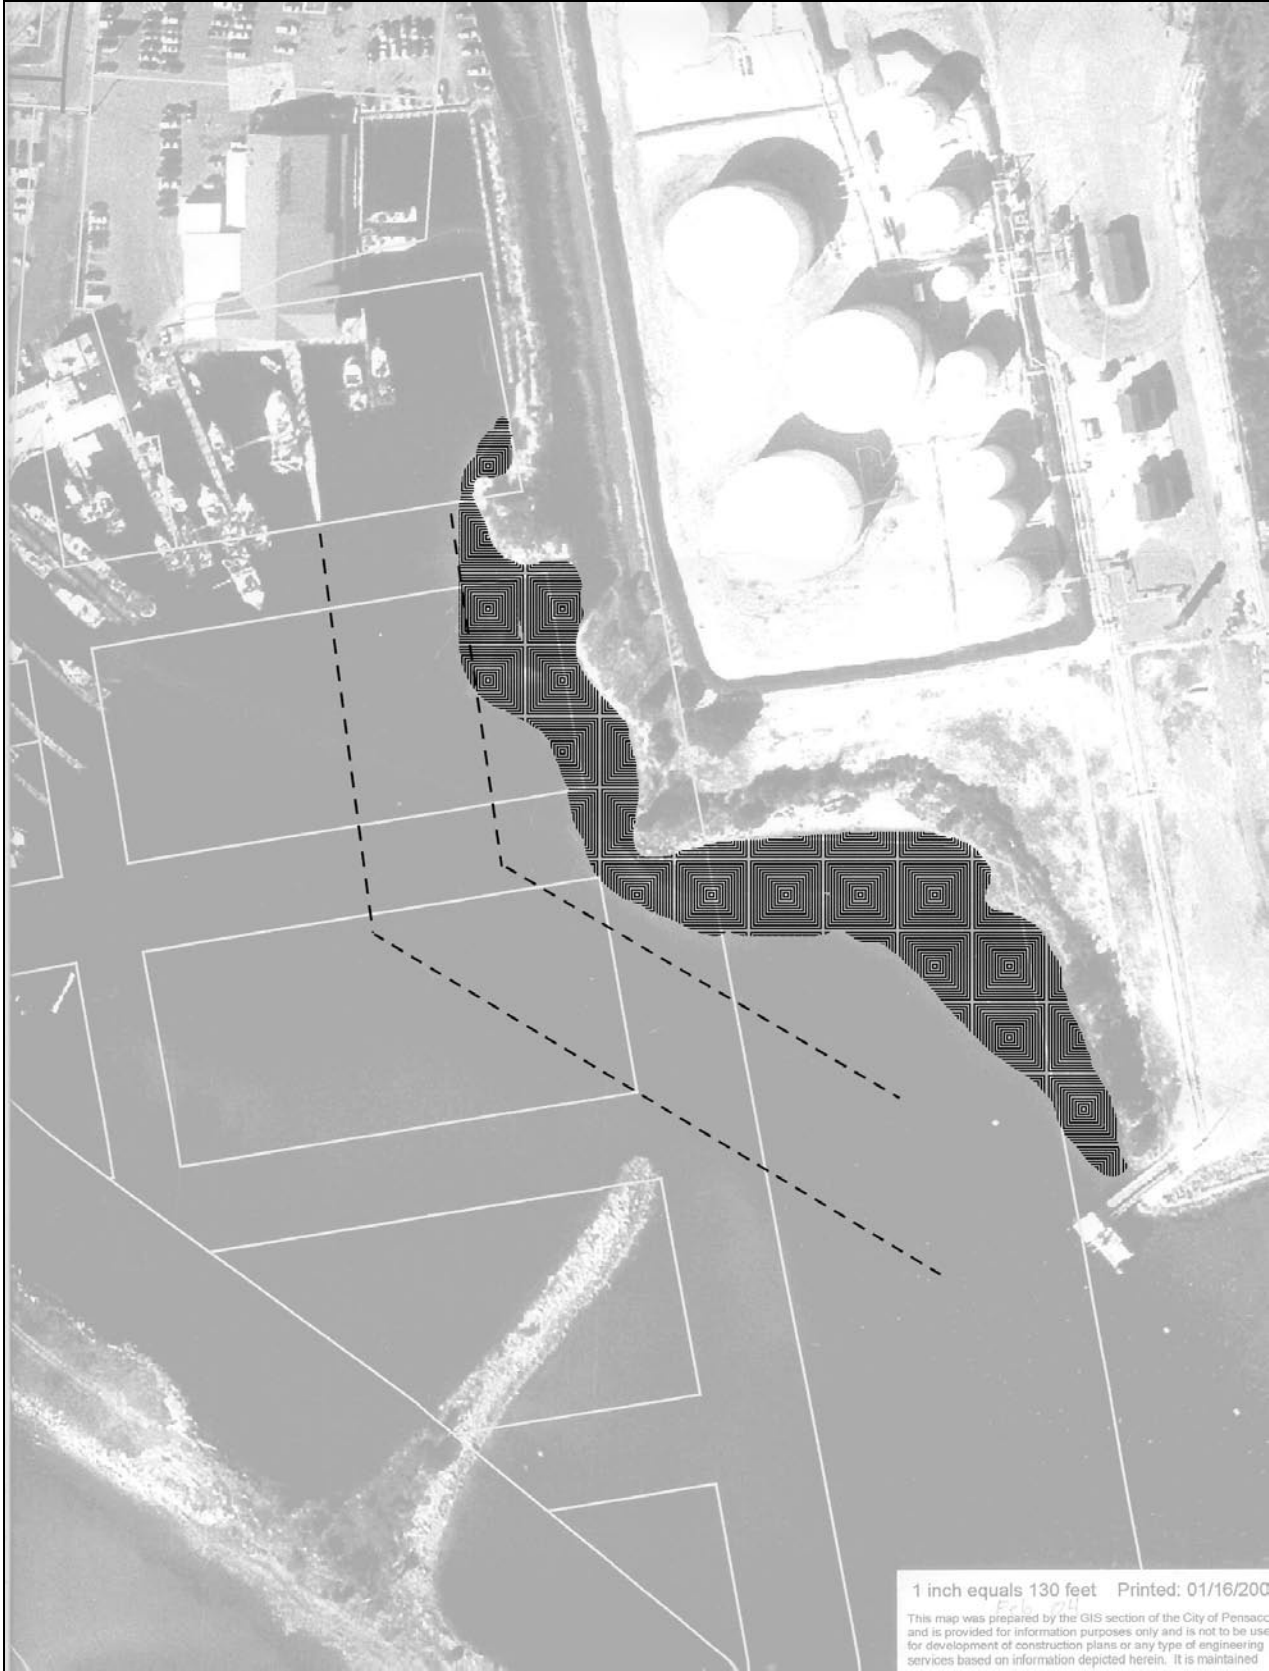
Figure 5-d) Aerial Photograph of PSBH with Location of Cannel and Post Ivan Subaerial Deposition (crosshatched)
