Emerald Ocean Engineering LLC

SUBJECT: Perdido Key Dune: First Scheduled Site Inspection Report

The first scheduled post construction Site Inspection of the Enhanced Emergency Dune was conducted on May 2 2006. The date was selected to observe the impacts of a strong SE wind event before indicators were erased. Figure 1 shows the wind speed and direction data from a NWS meteorological station located on the open coast at Dauphin Island, AL for the three days prior to the inspection.

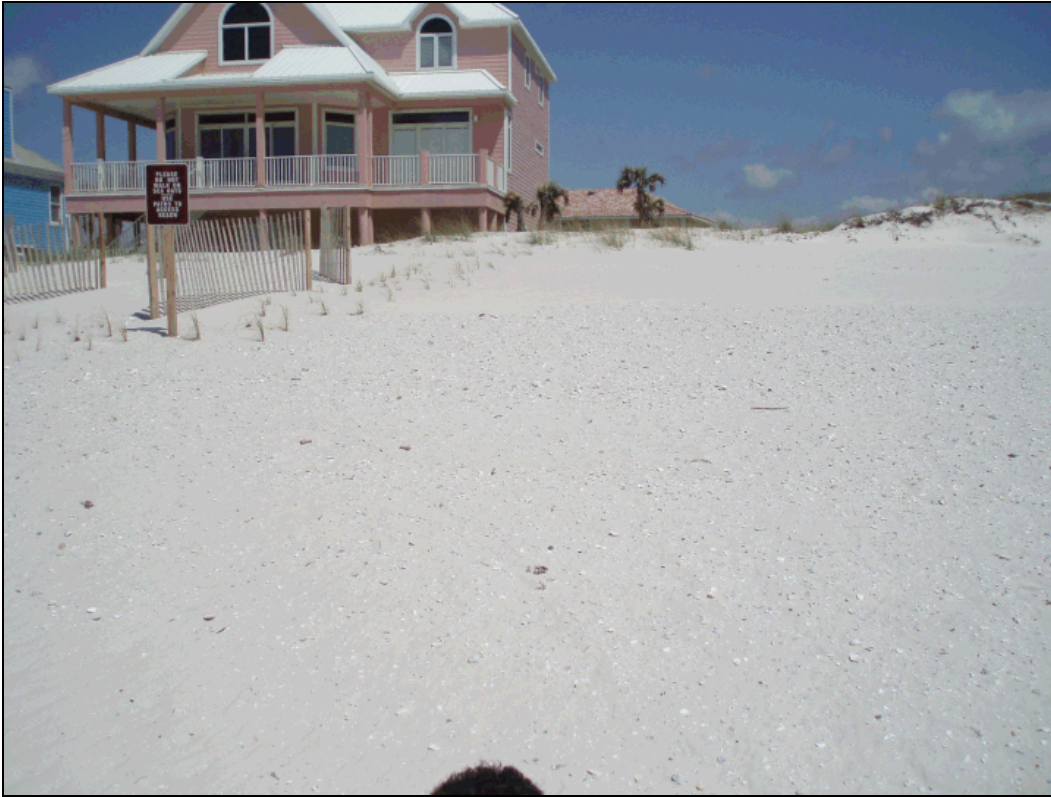
The principal reason more sand was not eroded by the wind was the self-armorings of the dune surface by the larger particles contained in the sediments – principally shell fragments. This armorings effect was most pronounced at those sites exposed to the most direct wind. The armorings effect was generally more noticeable on the Eastern Portion than the Western Portion, and consequently the erosion was slightly less on the Eastern than the Western Portion.

Example of distribution of areas of self-armor on dune foreslope. View looking north near station 100+00, east side. Armoring extends further upslope to right (windward) side of private sand fencing.

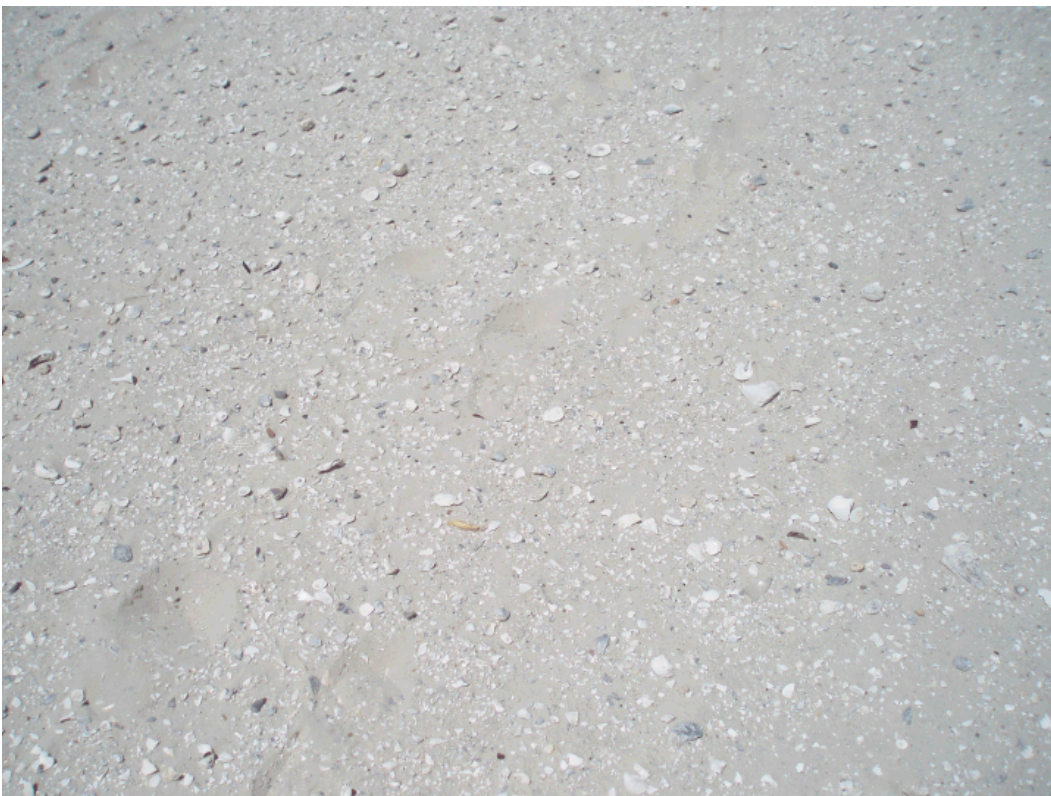
As long as the armorings of shell particles remains in place, additional erosion from subsequent wind events of similar magnitude will be negligible. Foot traffic is the most likely factor that would disturb this layer. Stronger winds, on the range of 50 + MPH, are at the threshold of tropical storm conditions. The approach of a tropical storm would probably be accompanied by a surge of several ft, which, combined with longer period wave runup, would begin to erode the dune significantly.

Close-up of self-armor by shell fragments. Note how easily footprints disturb the armor layer.

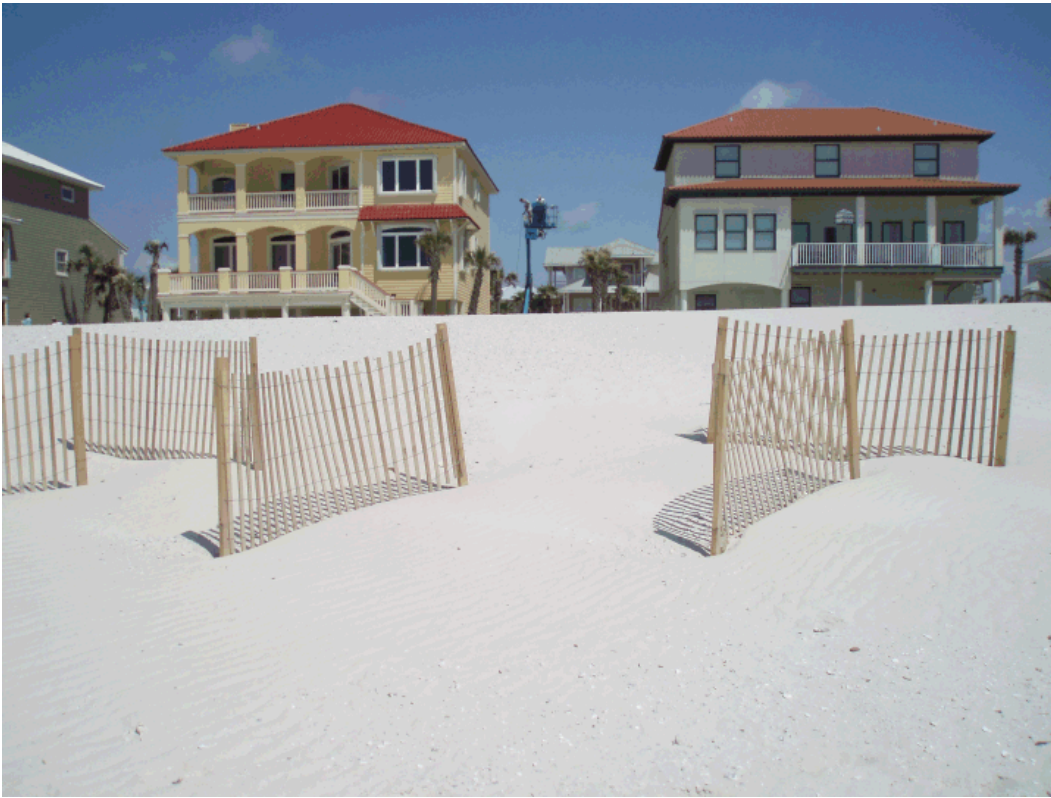
Accumulation of several inches depth of sand behind private sand fencing

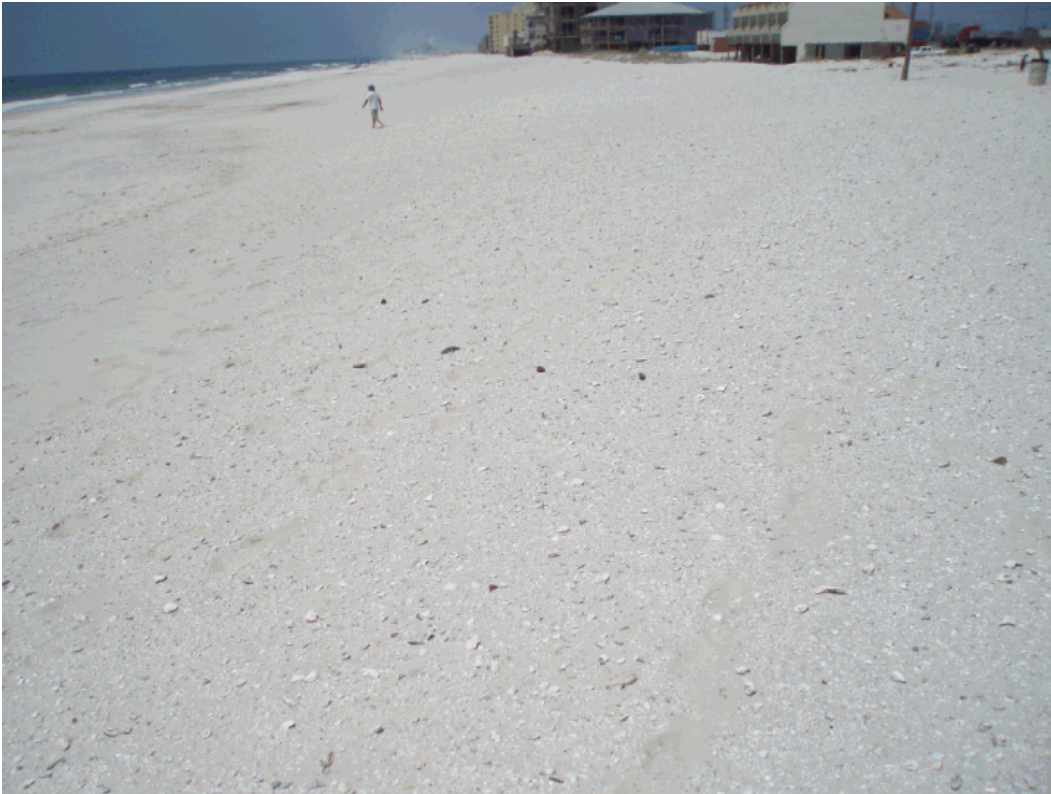
View looking west near station 60+00 , east side. Limit of wave runup is visible near toe of dune.

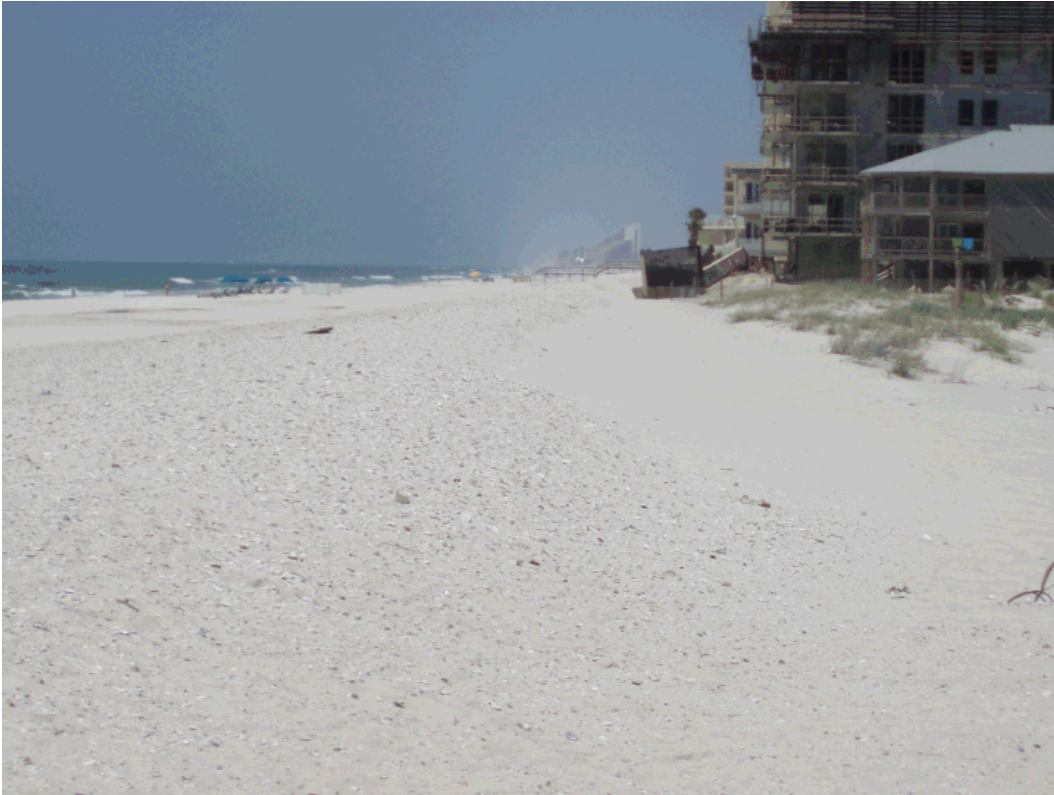
Accumulation of wind-blown sand immediately behind dune, with relatively little accumulation further landward.

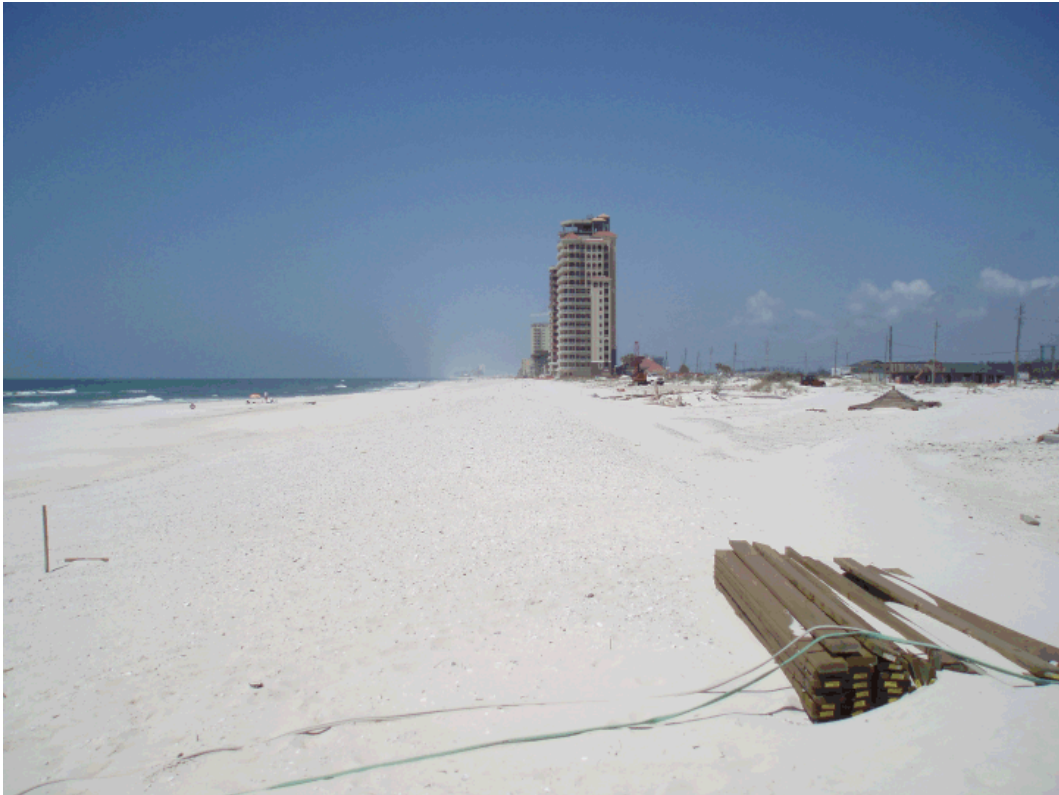
Localized deposition around lumber, with more modest accumulation behind dune away from obstructions.

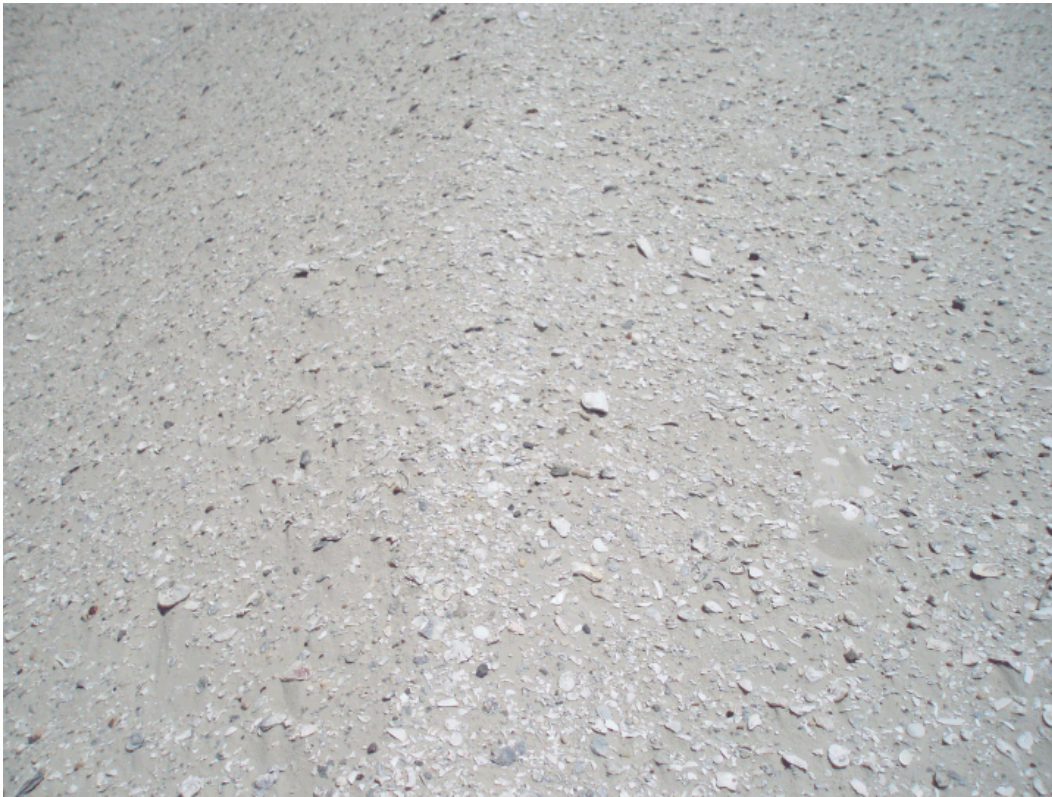
Another detail of self armoring.

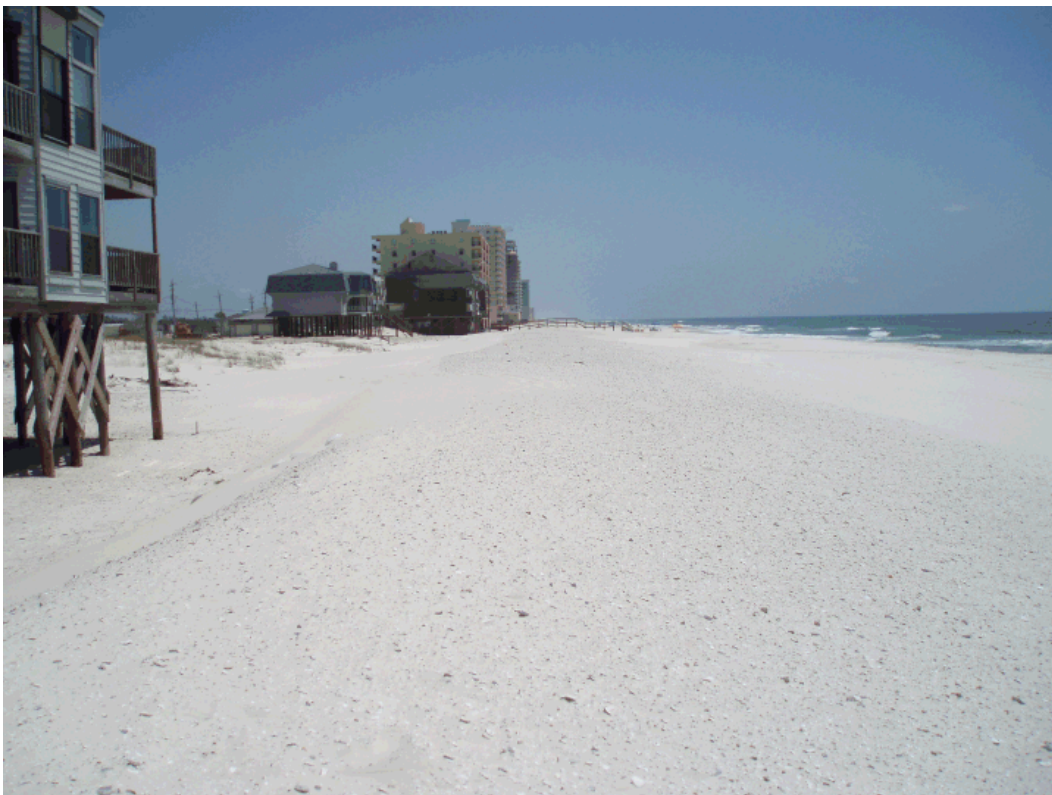
Reduced deposition behind dune on windward side of structure.

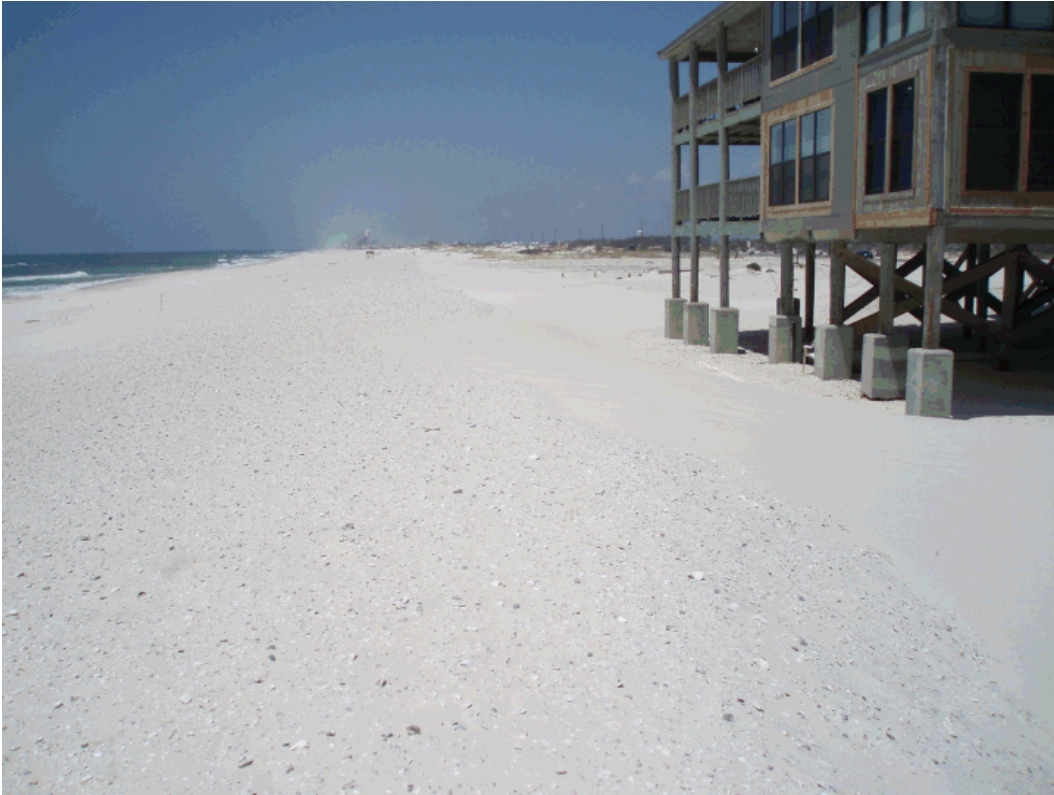
Reduced deposition behind dune directly in front of structure, and increased deposition in lee.

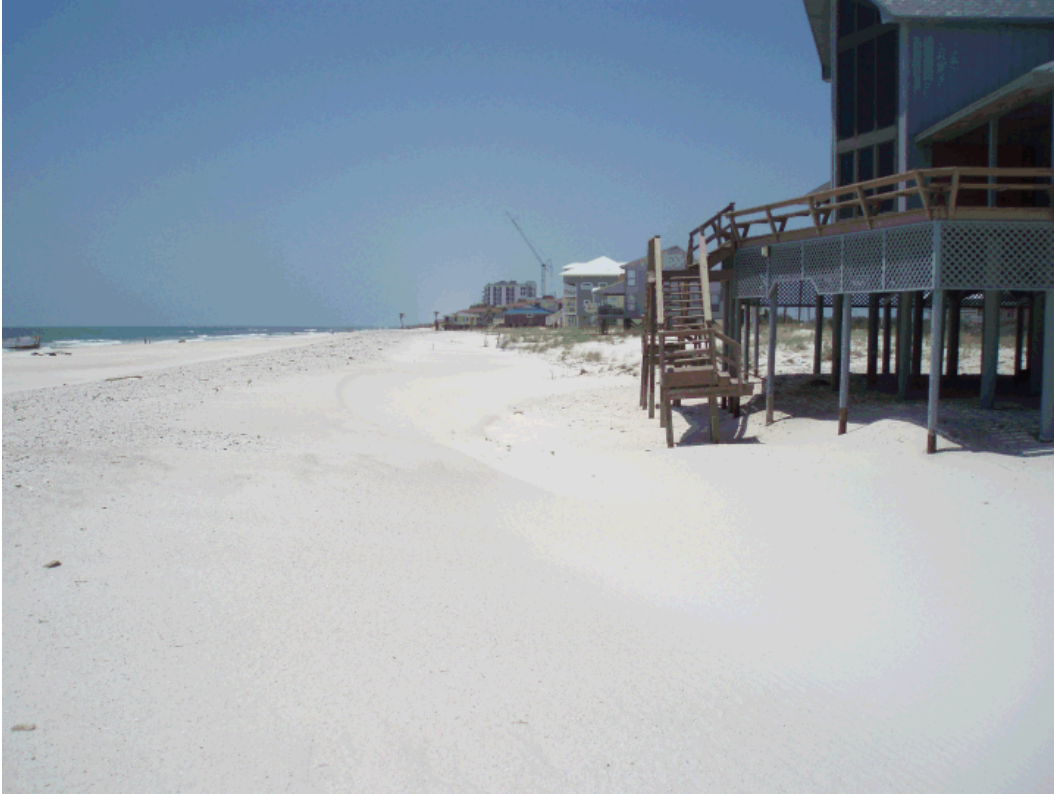
Another illustration of localized impact by a structure.

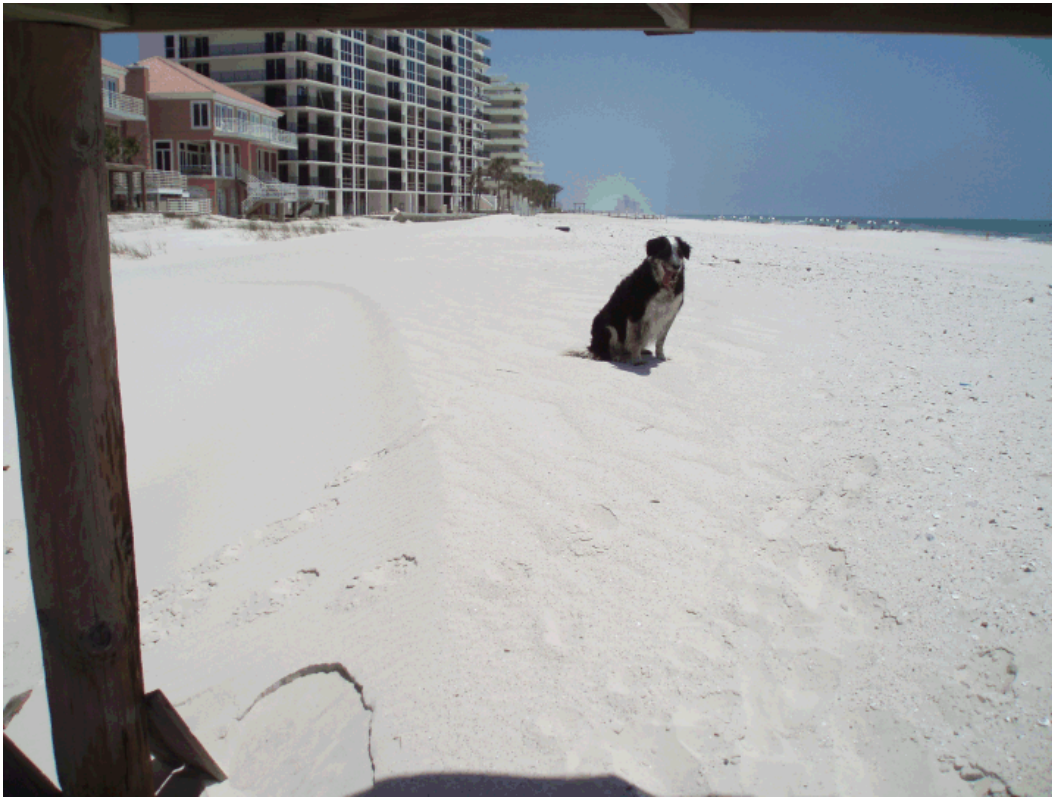
More significant accumulation (up to 1 ft thick) behind dune caused by walkover. Note dog for scale.

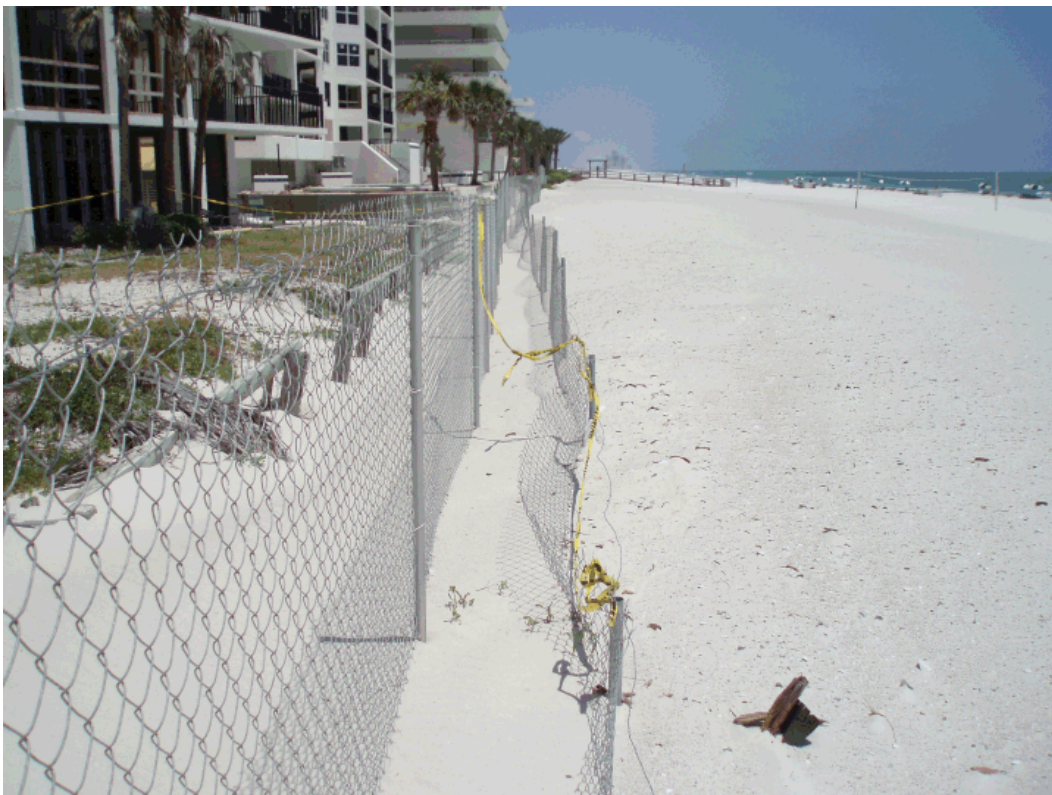
Good illustration of quantity of sand accumulated behind dune. Note relative modest burial of grass behind fence.

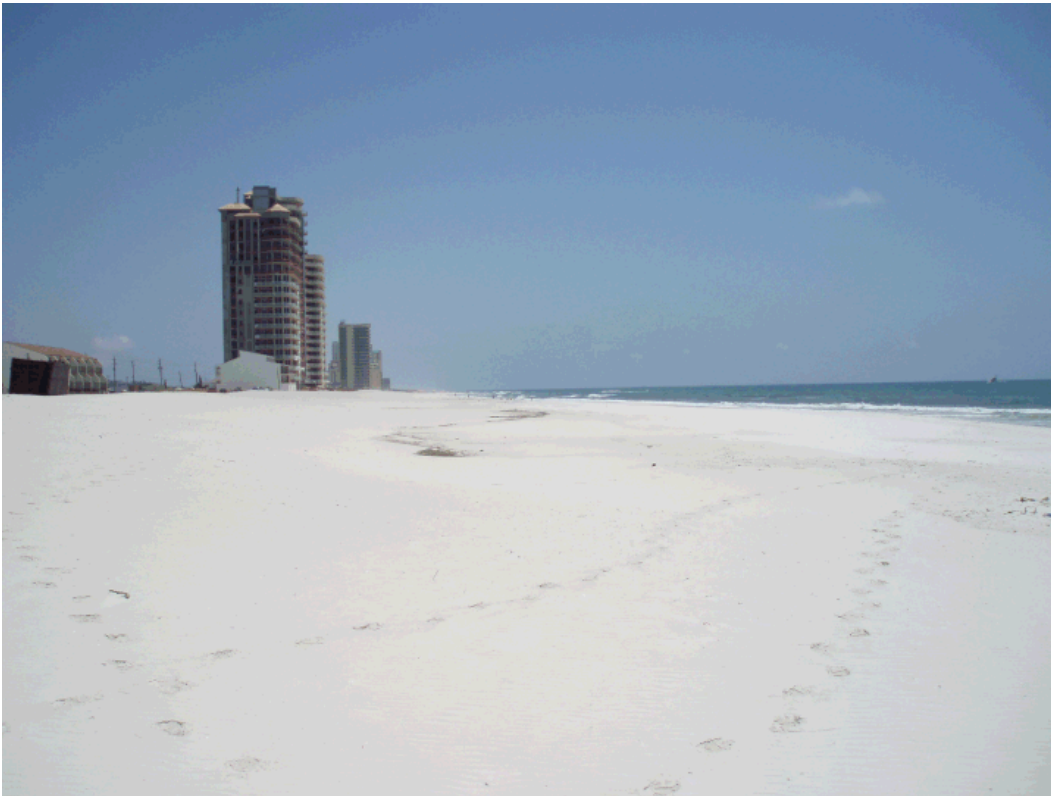
Runup approached dune toe on western side. Note reduced degree of self armoring.

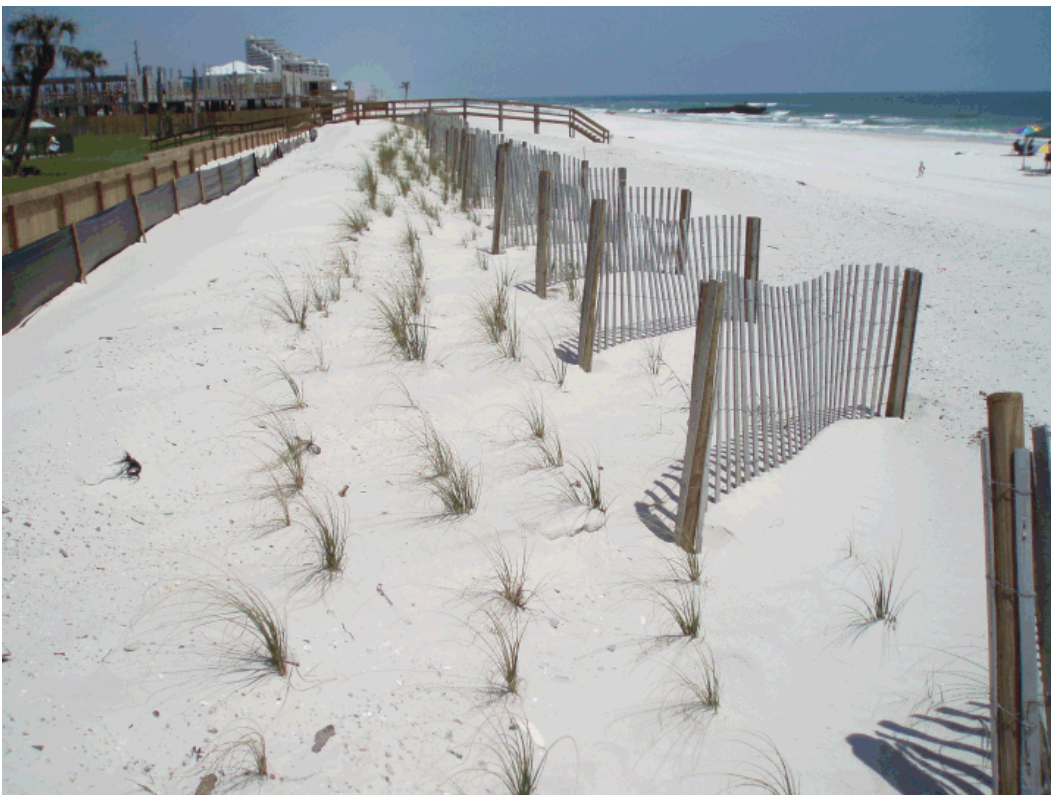
Relatively modest accumulation by sand fences, due to alignment with wind direction.

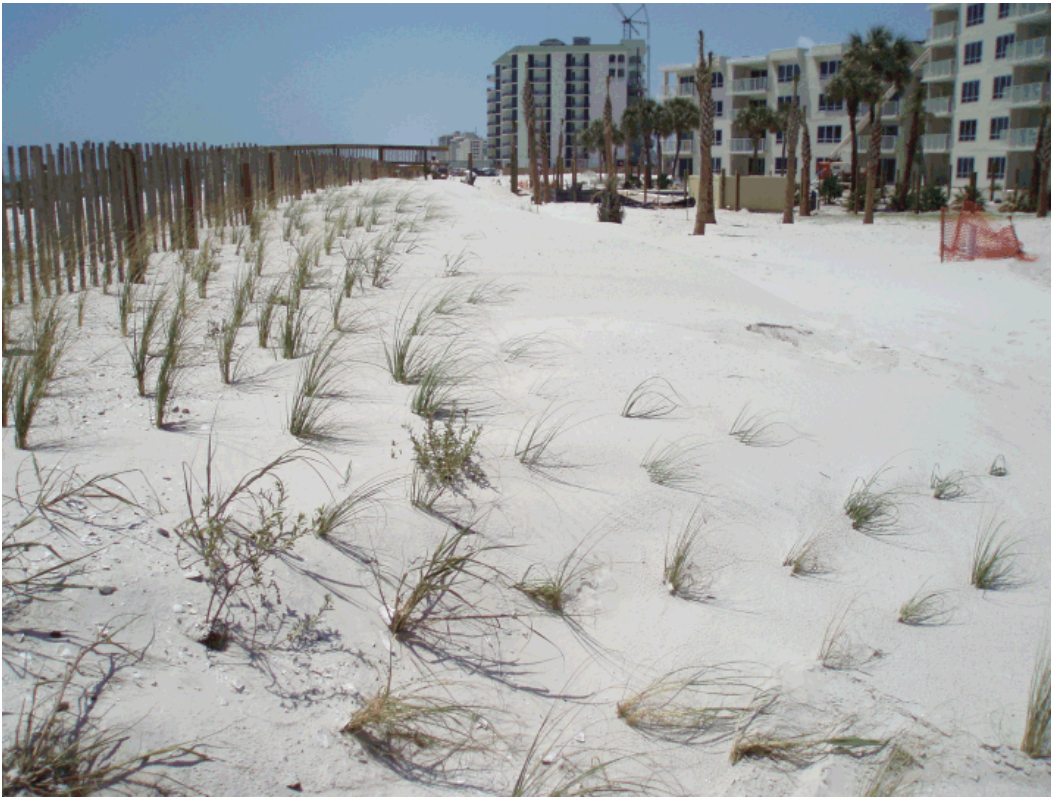
Burial of some grasses on back of dune, relatively far from sand fencing, while there is no deposition in immediately behind sand fences.

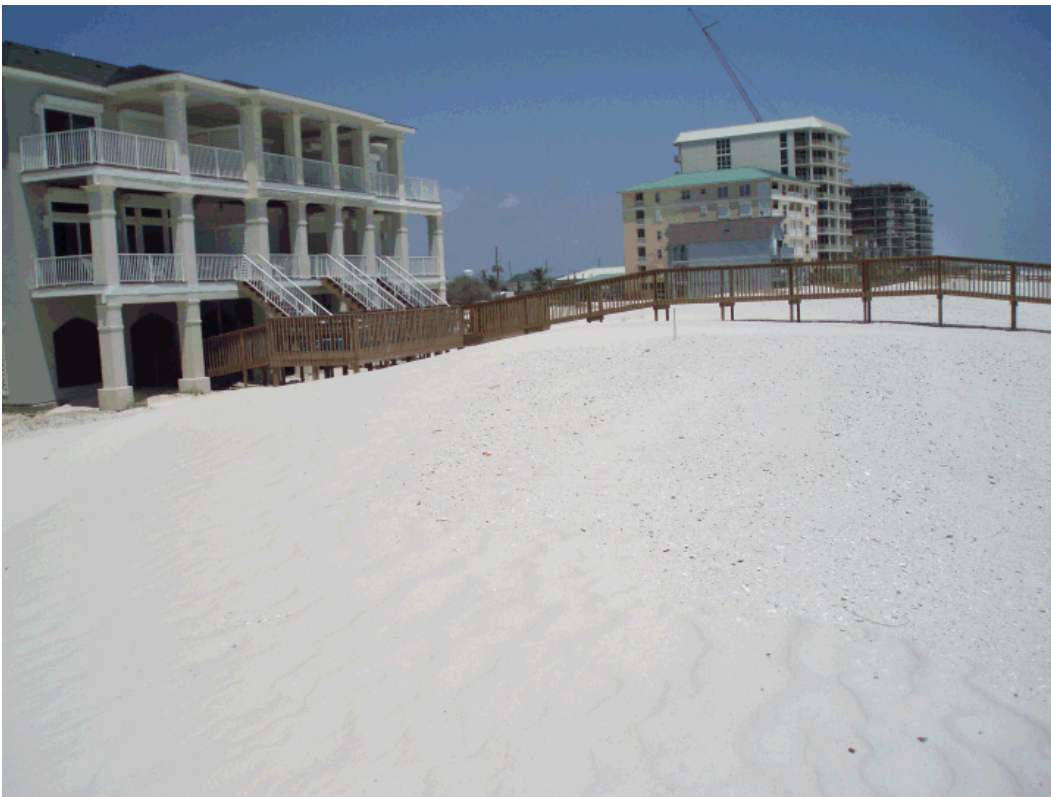
Walkover serving as large scale sand fence.

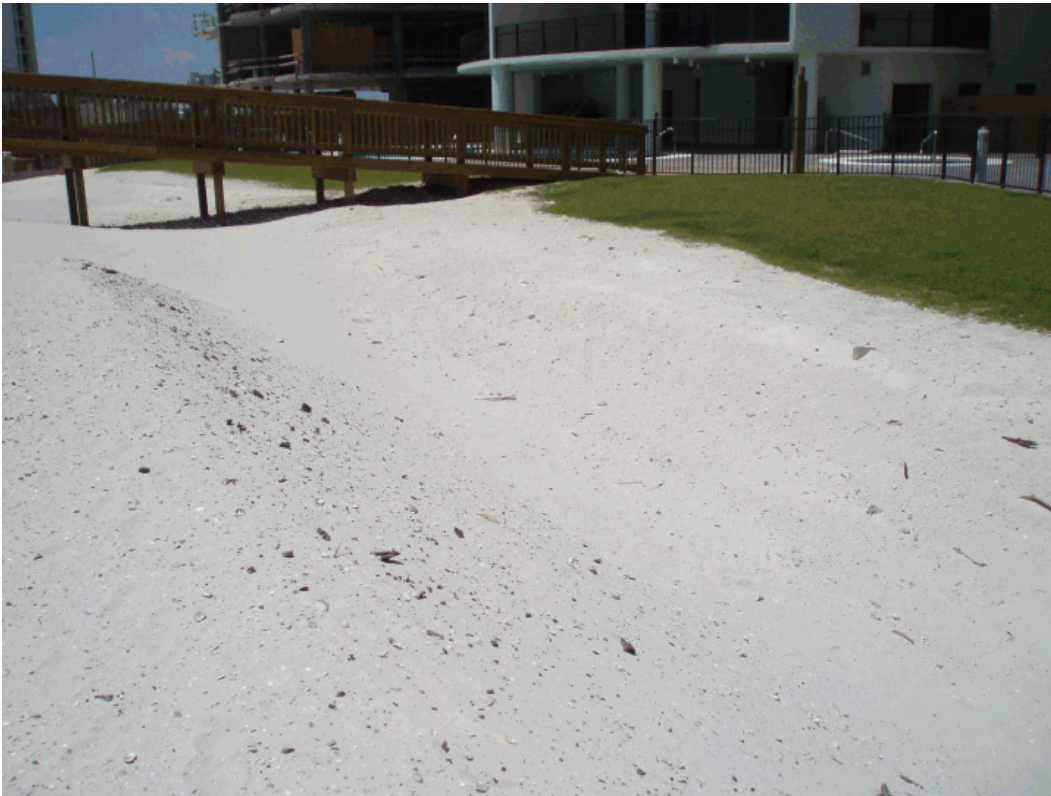
Another example of quantity of sand transported landward by event.

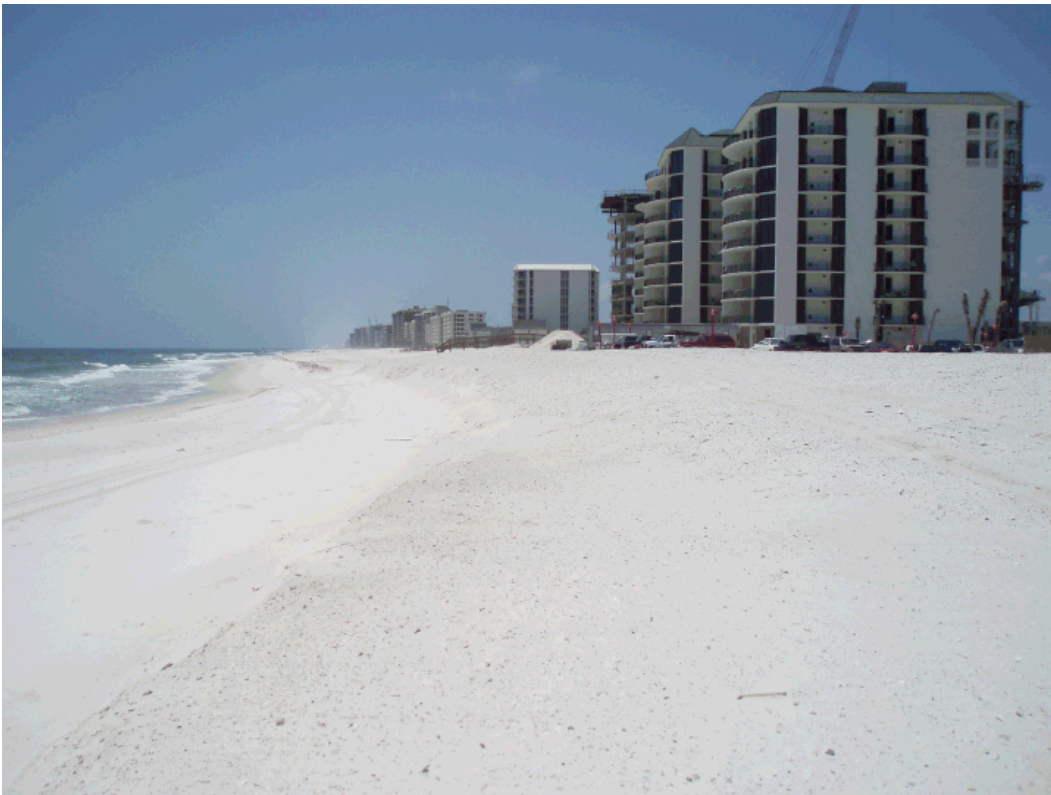
While wind erosion was no more pronounced than normal between stations 64+00 and 66+00 (behind the Crab Trap Restaurant), the foreslope of the dune at this location experienced moderate wave erosion. This is a result of the severe seaward displacement of the dune, as described in the memo of April 3, 2006 describing the As-Built surveys. Figure 11 shows the actual and design position of the crest at this location. Figure 12 shows an erosion scarp forming at the base of the dune. In other locations the wave runup approached the toe of the dune, but no further.

Indentation in shoreline directly behind Crab Trap Restaurant.

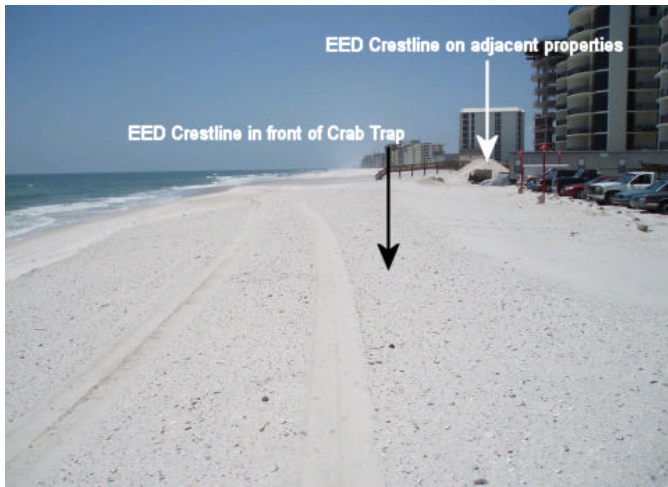
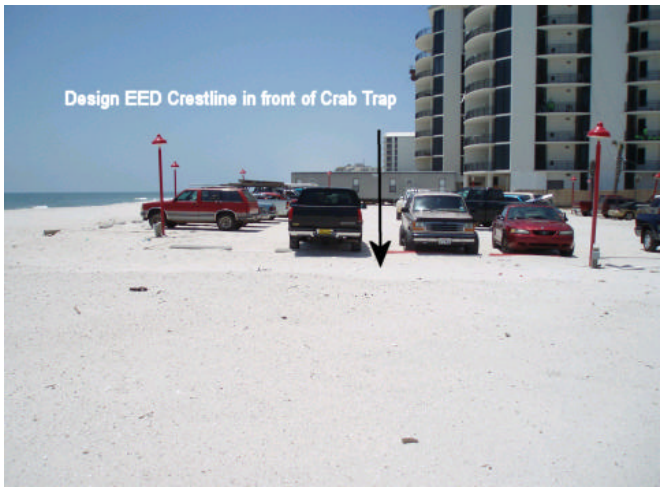
Actual and Design Location of EED Crest behind the Crab Trap Restaurant

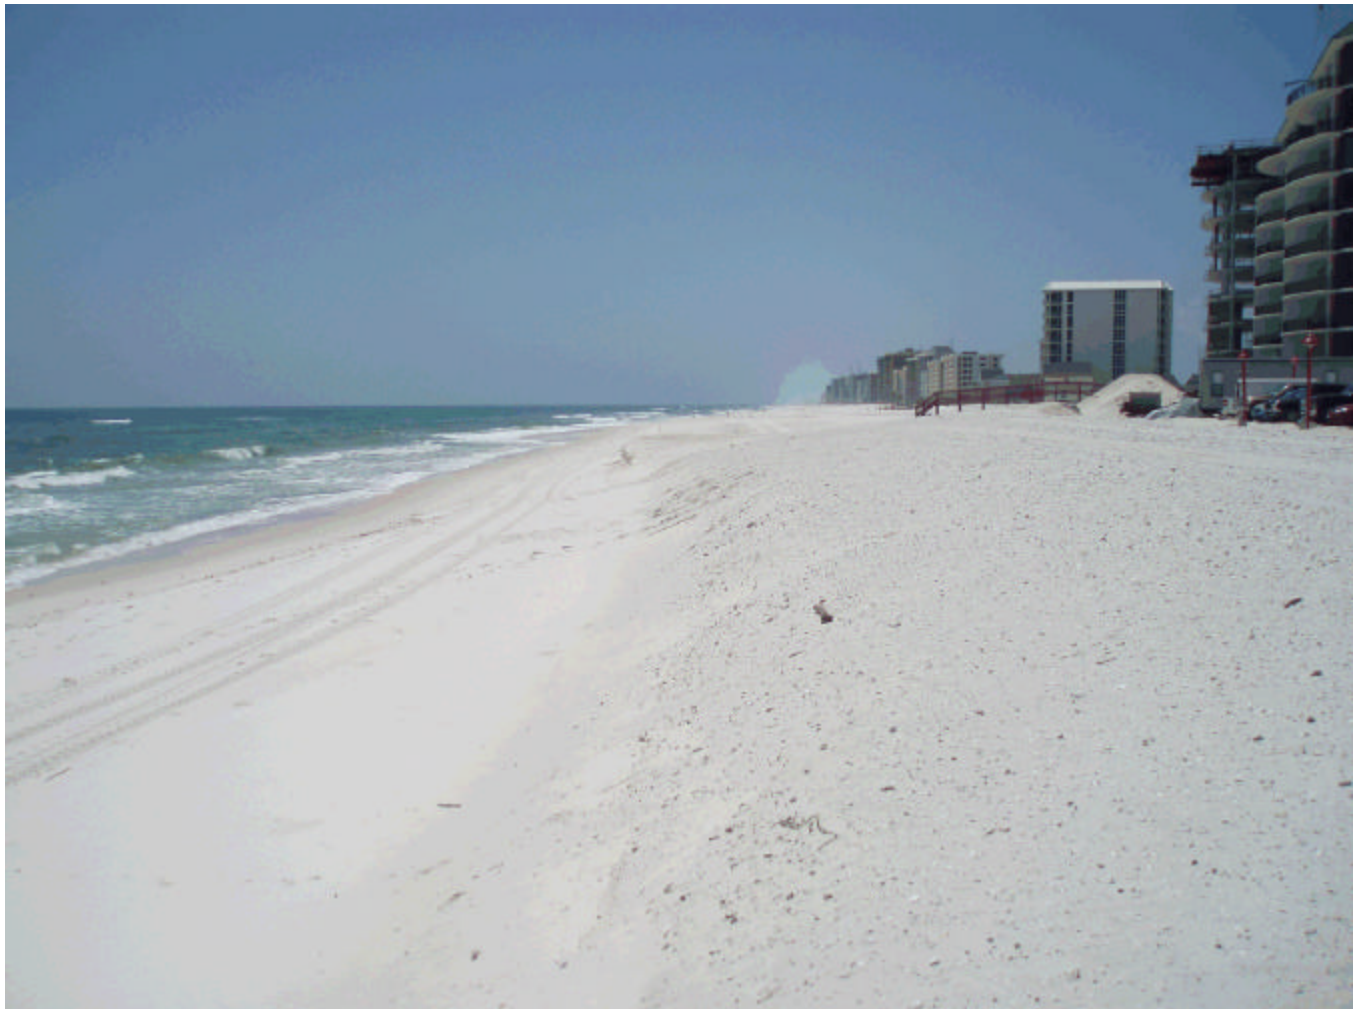
Erosion scarp on dune face behind the Crab Trap Restaurant, observed on March 2, 2006
