Design and Monitoring of a Small Living Shoreline Scaled for Private Properties on Exposed, Rapidly-Eroding Coasts

D. D. McGehee

Emerald Ocean Engineering LLC
Pensacola Beach, FL 32561
USA

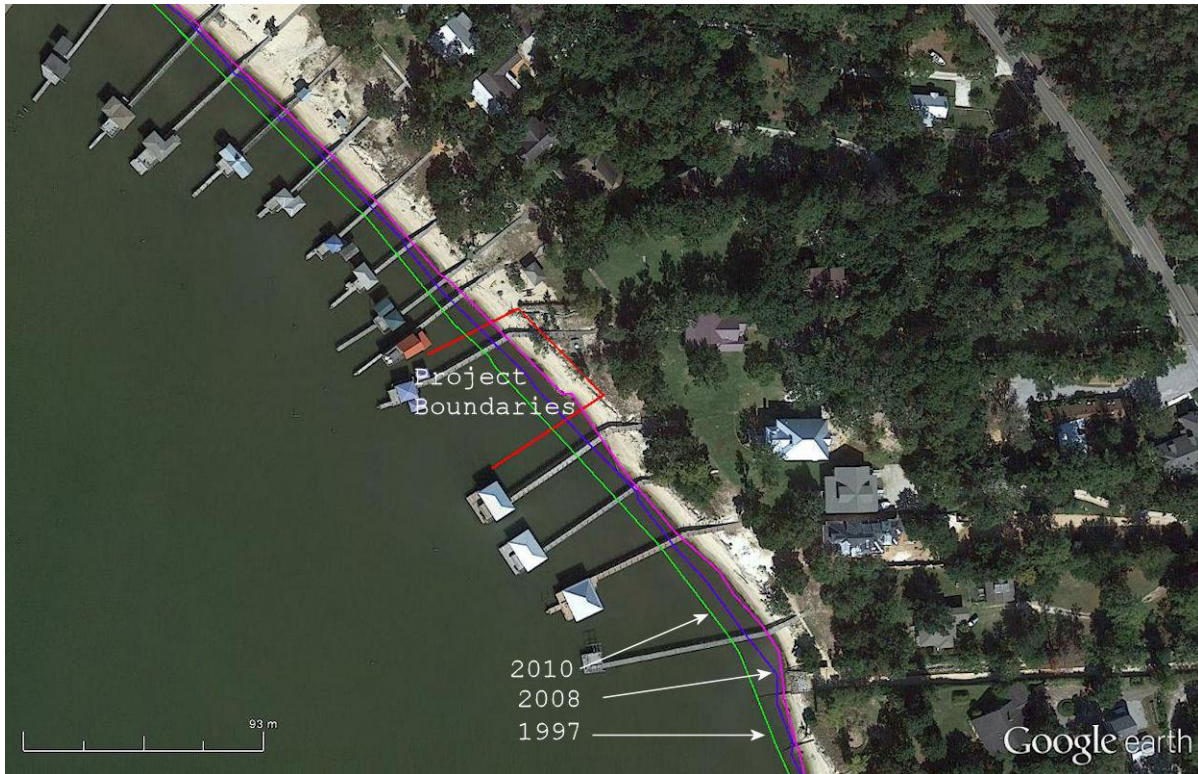
Figure 2. Project site on aerial photo from 11/02/2013 with historical shorelines from 1997, 2008, 7 2010

All of the unprotected shorelines in the general vicinity are retreating, but the most severe erosion observed in the study area, about 60-90 cm/yr, is just south of the project (Figure 2). The obvious question that arises from the LST calculation is this: if net LST comes from both directions toward this site (a LST node), why is it eroding at the fastest rate instead of accreting? Three other factors need addressing to explain the erosion:

The second factor is cross-shore transport (CST), i.e., movement of sand perpendicular to the shoreline. Offshore-directed CST is episodic and occurs almost exclusively during higher wave events; it is insignificant below some energy threshold. Storms produce larger, steeper waves that pull sand from the shoreline offshore to create bars (sometimes called “storm bars”). On an open ocean coastline, swell waves – lower waves with longer periods – occur after and between storms. Swell transports the sediments on the bar shoreward, so in the long-term (and with a constant sea level), cross shore transport is in equilibrium. Mobile Bay often experiences high enough winds and the site has sufficient fetch to produce highly erosive, steep, short-period waves. However, there is insufficient fetch to generate the long-period swell that moves the bars shoreward. Thus, the shoreline retreats with each high wave event and does not fully recover in between. Quantitatively, comparison of the eroded upland volumes with measured offshore profiles taken during the site analysis phase showed that all of the sediment volume lost from the upland shoreline between 1997 and 2013 can be accounted for in the underwater bars within 61 m (200 ft) of the shoreline.

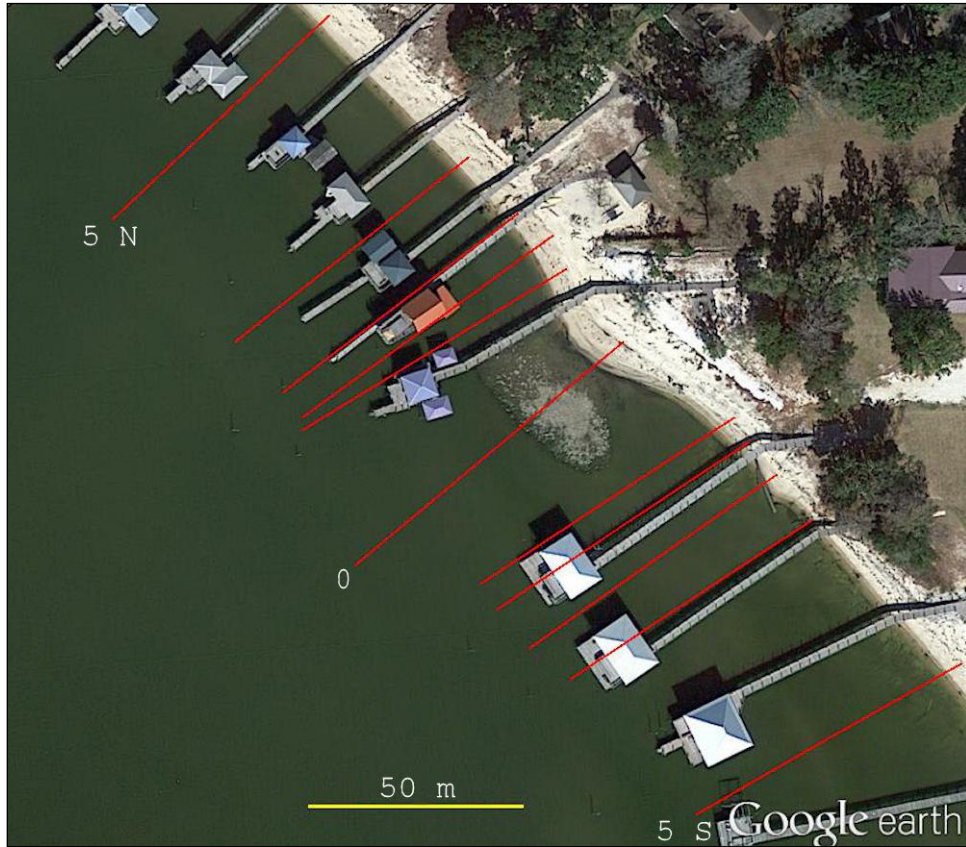
Figure 4. Project post construction, 1/30/2015, with survey profiles 5S through 5N

Permits for the project were received in February of 2014, and construction commenced the following May. In June, the Alabama Department of Conservation and Natural Resources issued a unique requirement to conduct semiannual monitoring for three years following project completion. Eleven profiles extending up to 61 m (200 ft) offshore and photographic documentation are required each spring and fall. Three profiles cover the north, center, and south bounds of the project, and four pairs of profiles are spaced 7.6 m, 15.2 m, 30 m, and 75 m north and south of the project bounds. Figure 4 shows the location of the profiles, numbered consecutively from the center of the project (profile 0) outward to the south and north (profiles 1S - 5S & 1N - 5N, respectively). Each profile was measured using wading survey methods and local instantaneous water levels as a datum. Elevations were adjusted to MLLW using measured water levels at the time of each profile from nearby National Ocean Service tide gages (Figure 1). To date, surveys have been made on October 8, 2014; May 2, 2015; and September 19, 2015. Additional site visits were photo documented in July of 2013; in June, July, August and December of 2014; and in August, September, and October of 2015.

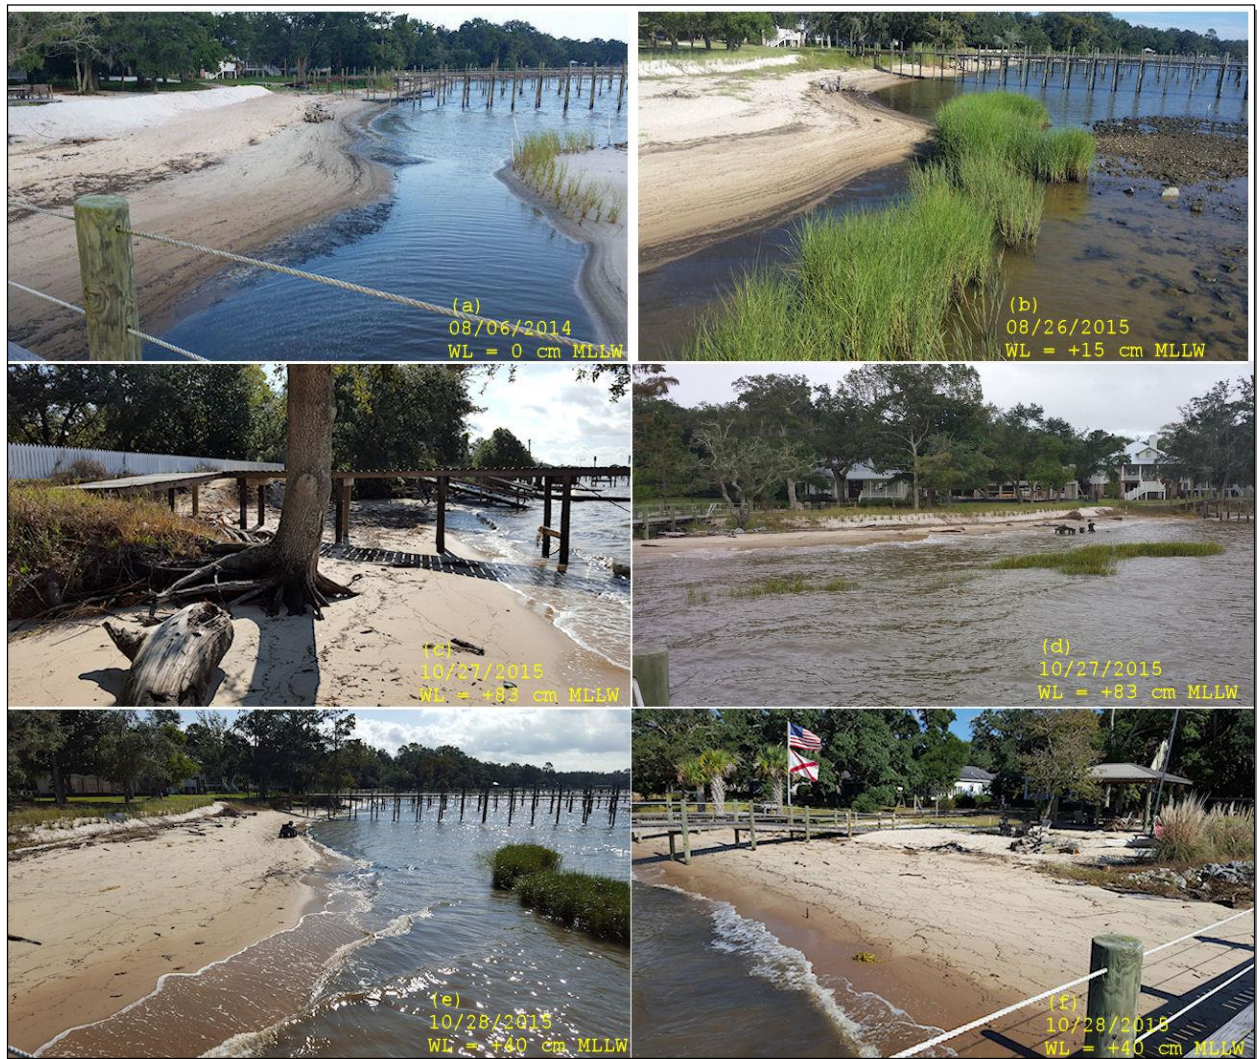
Figure 6. Sequence of ground level photos of the completed project and adjacent shorelines.

Figure 6 is a sequence of ground-level photos of the project and nearby shorelines. Figure 6(a) was taken one week after construction of the offshore portion but before the berm was vegetated. A minor salient has already begun to form. Figure 6(b) was taken about one year after construction. The salient has prograded to a tombolo, but neither the photo nor the surveys in Figure 5 reveal observable erosion of the adjacent shorelines. Material for the tombolo could also be coming from the pre-placed sand in front of the berm and/or from deeper water offshore of the breakwater. Implementation of the adaptive management plan was discussed at this time, but it was decided to wait until the following spring to see if higher wave conditions would reduce the tombolo. It is apparent that the emergent marsh is thriving.

A moderate storm occurred on October 25, shortly after the fall 2015 survey, that produced winds from the southeast near the design conditions and water levels exceeding the design water level. Incident waves were not measured but probably did not exceed the design wave because of the reduced fetch to the southeast. No post-storm surveys were conducted, but a site inspection showed that shorelines to the south were noticeably eroded (Figure 6(c)). Figure 6(d), taken two days after the peak of the storm shows remnant waves passing over the reef and through the marsh before impinging, much attenuated, on the shoreline. There were no impacts to the marsh or the backshore, but the tombolo that formed under mild wave conditions had been reduced considerably (Figure 6(e)). Figure 6(f), looking northward from the project site, illustrates how a significant portion of the tombolo was transported northward and deposited on the adjacent foreshore, verifying that LST continues under higher wave conditions. Subsequent surveys will determine if the effect is persistent and quantify volume of sediment transported in the longer term.
